Aging and Contamination Evaluation Status

Insulation Blanket Films

Boeing Commercial Airplanes
Material & Process Technology

November 19th, 2003

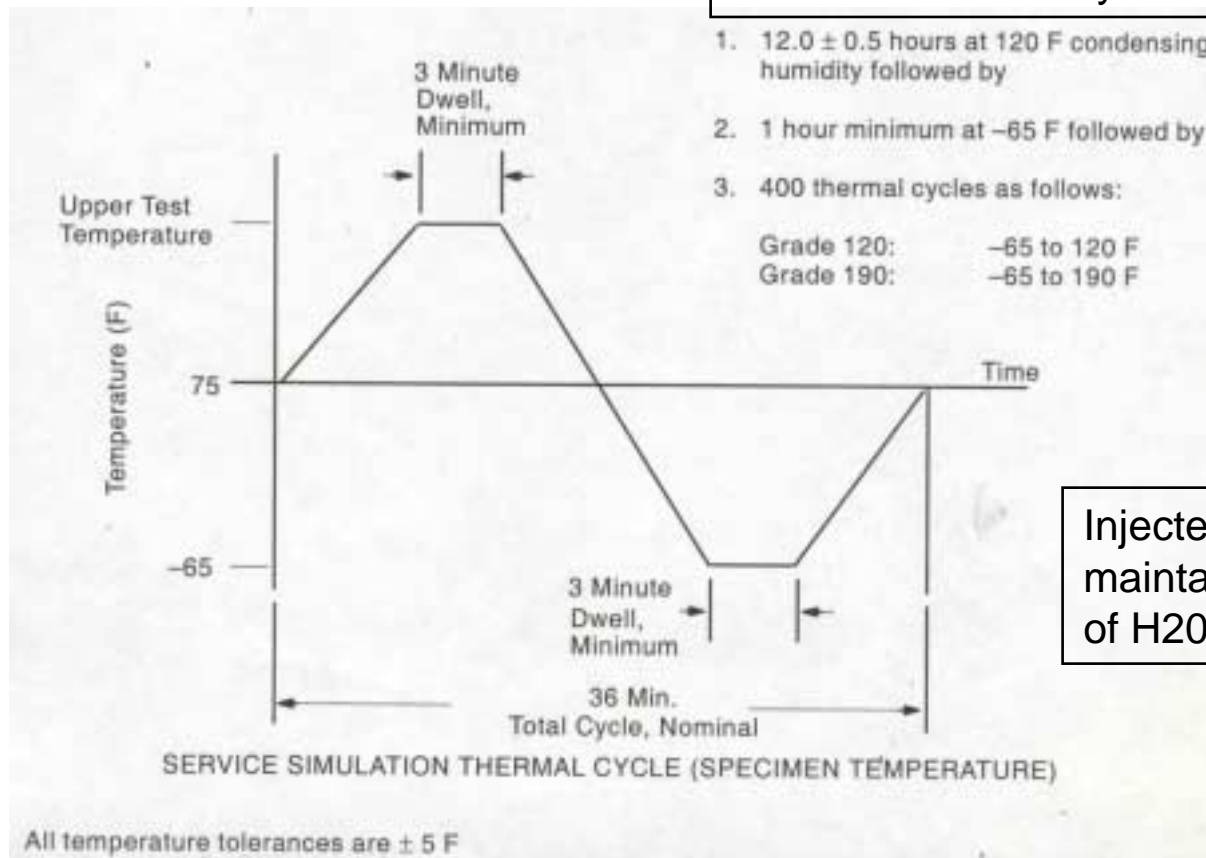
-Thermal Cycle –

One Block is 400 Cycles.

Injected and maintained 40 grams of H₂O.

Note: 2000 cycles is equivalent to an airplane life cycle; ~ 50,000 cycles. Cycle developed to evaluate composite matrix cracking. Used in-service exterior aramid fiber/epoxy honeycomb parts to correlate actual flight cycles with simulated flight cycles.
