FINAL REPORT

Contract No. FA67NF-210  
Project No. 520-003-01X  
Report No. NA-68-22  
(DS-68-10)

METALLURGICAL EVALUATION OF AIRCRAFT  
EXHAUST SYSTEM COMPONENTS FAILED DURING  
GROUND TEST PROGRAM

April 1968

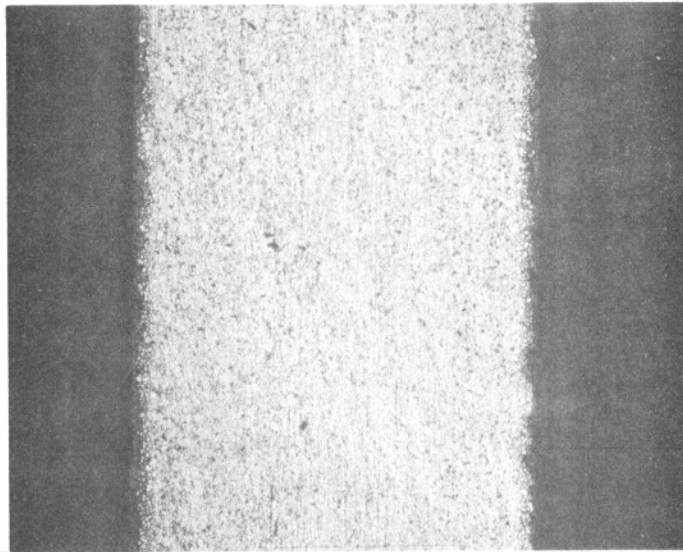
Figure 3

Showing both surfaces as polished.  
(Outside surface at right)

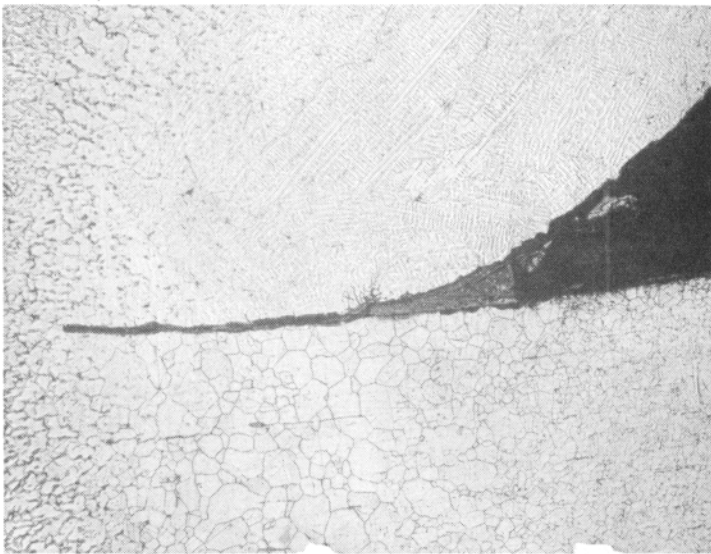
Figure 9

Metallographic specimens were taken from each component of the welded assembly. Figures 9 and 10 show the weld joint to be normal with some grain growth in the heat affected zone.

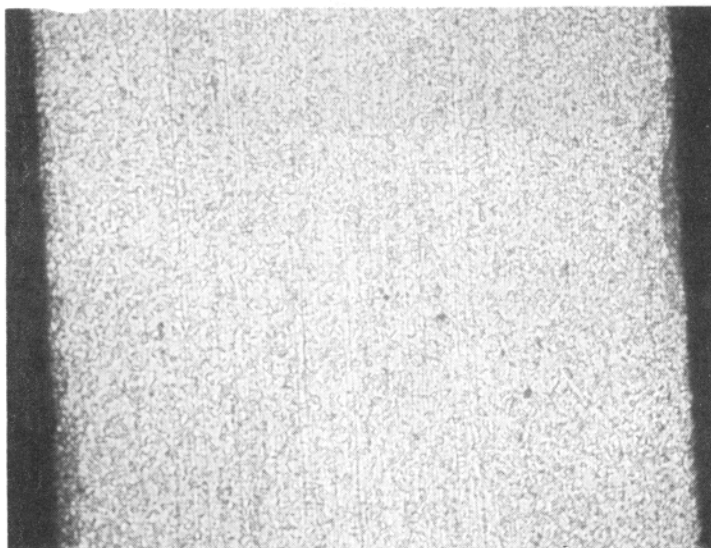
Figure 11

Other specimens were cut on one side of the crack and examined for general structure and the cause of failure. Figures 11 and 12 show the normal 347 structure with some evidence of delta ferrite. Figure 13 shows the inside edge along the crack in Specimen No. 3.

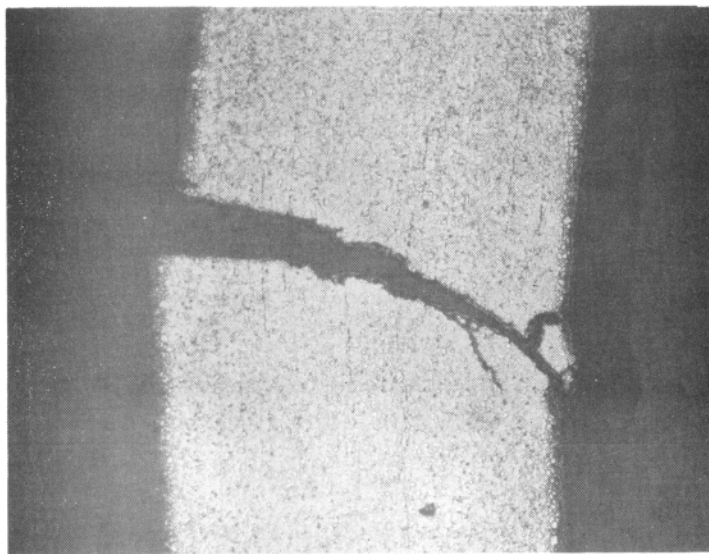
Figure 16

A metallographic specimen was cut to view the end of a crack which had developed perpendicular to the circumference of one of the holes in the baffle. Figure 15 shows the crack with two branches, (also see Figures 16 and 17). Columbium carbides are visible in these figures.

Showing end crack in shell and  
columbium carbides.  
As polished.

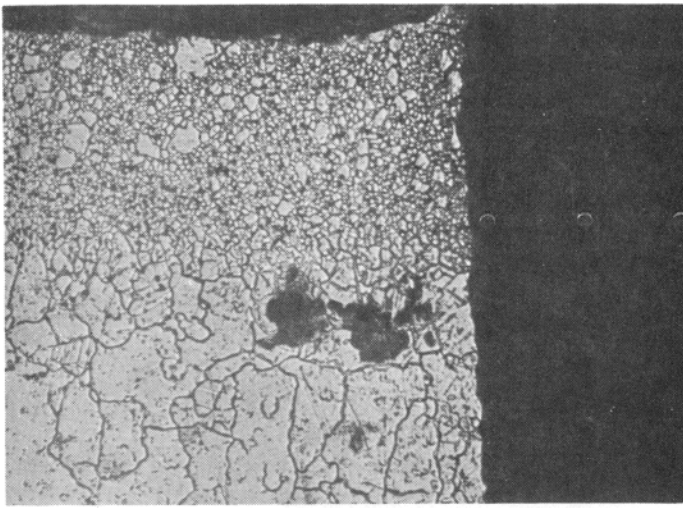
Figure 21

Showing grain growth.

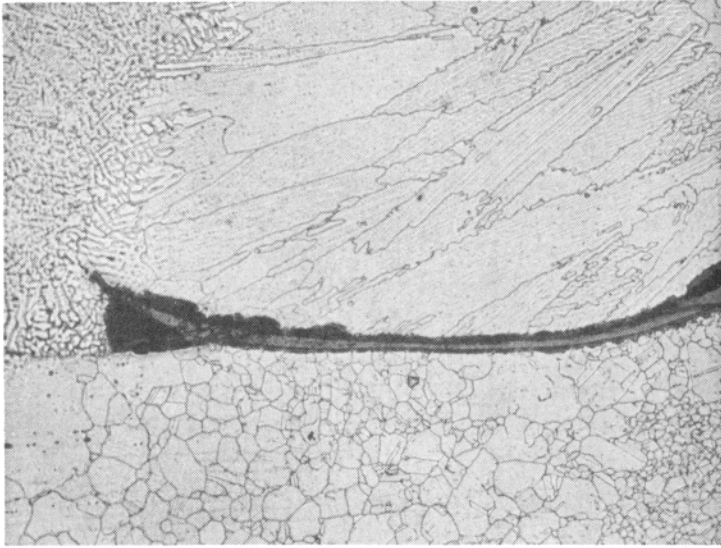
Figure 28 shows one of the welded joints in Sample No. 7. The weld material, heat affected zone and base metal are typical. The general structure of the sample is shown in Figure 29.

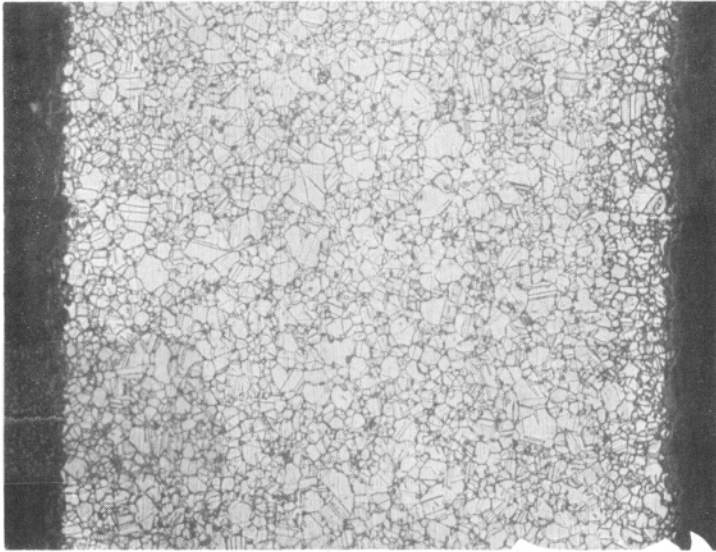
Figure 39

The microstructure at the two locations after etching are shown in Figures 39 and 40. The structure around the crack contained sigma phase distributed discontinuously in the grain boundaries, and severe oxidation.

Deeper penetration at various  
locations on outside surfaces.

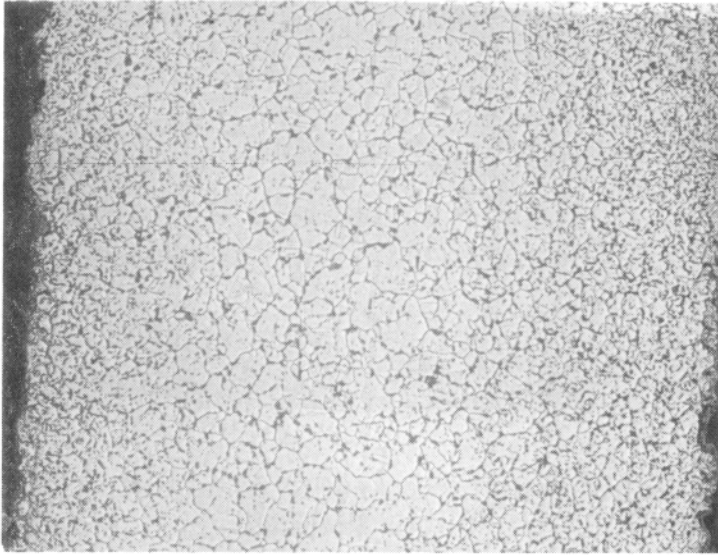
Figure 44

Figures 42 and 43 show the difference in thickness of oxidation on the different cones. Examination of the microstructure, (Figures 44 and 45), revealed a substantial amount of sigma phase in the grain boundaries and some within the grains.

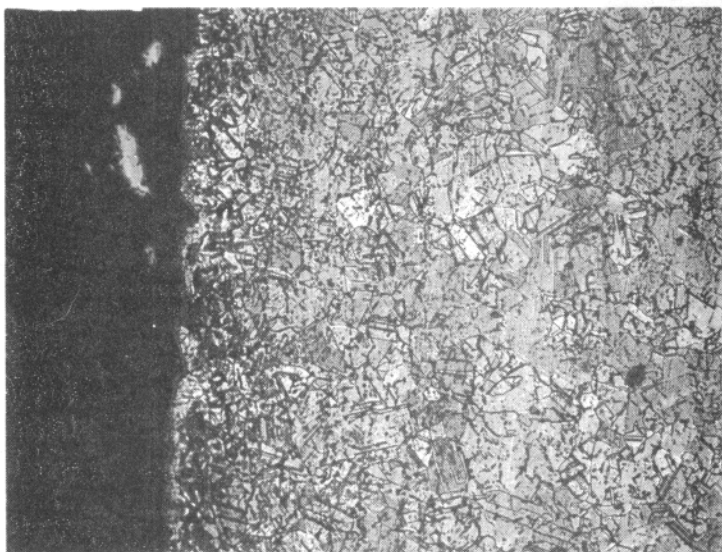
Figure 53

Metallurgical specimens were cut from all of the three cones (Incoloy Alloy 800). The microphotographs of the samples in the unetched condition showed very little oxidation. Many titanium cyanonitrides were evident as shown in Figures 51 and 52. Figures 53 and 54 show the general structure of one of the cones from Sample No. 14-15.

Showing general structure at  
inside surface.

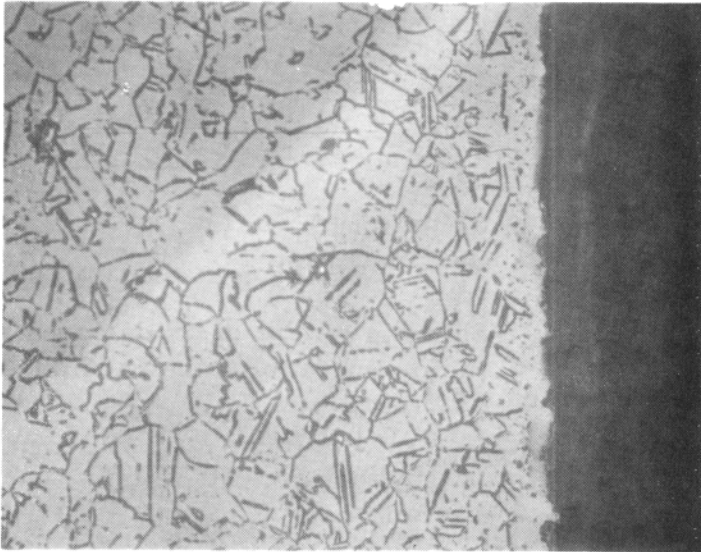
Figure 58

Metallurgical specimens were taken from the wall and the stud. Figures 56 and 57 compare the extent of oxidation on the inside edge of the AISI 321 stud and the Incoloy Alloy 800 wall. The general structure and titanium cyanonitrides are shown in Figures 58 and 59.

Showing general structure and  
titanium cyanonitrides.

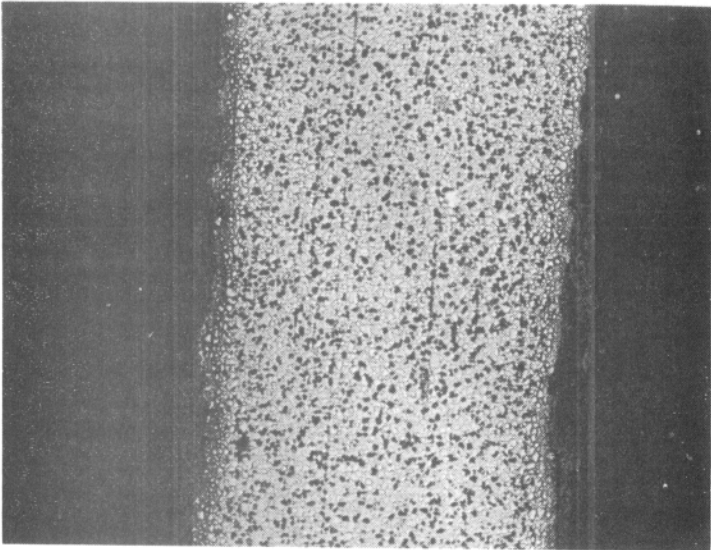
Metallographic examination in the unetched condition revealed a deep penetration of oxidation on both the inside and outside surfaces and columbium carbides. This condition is shown in Figure 61. Figure 62 shows the general structure of the sample. Intergranular corrosion is evident on the internal and external surfaces and there is a great amount of sigma phase present in the grain boundaries.

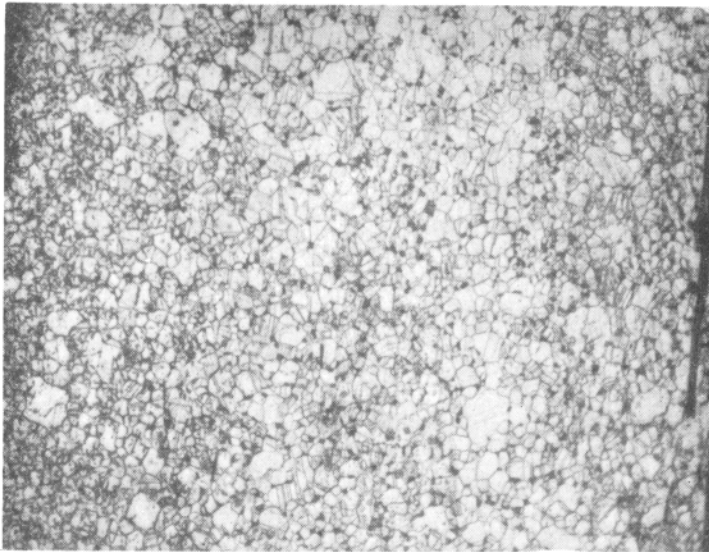
Figure 65

Metallographic investigation showed the penetration of oxidation and the presence of columbium carbides. As in previous cases, the oxidation was greater on the inside surface as shown in Figure 64. Examination of the etched specimens (Figure 65) showed some sigma phase in the grain boundaries and a typical general structure.

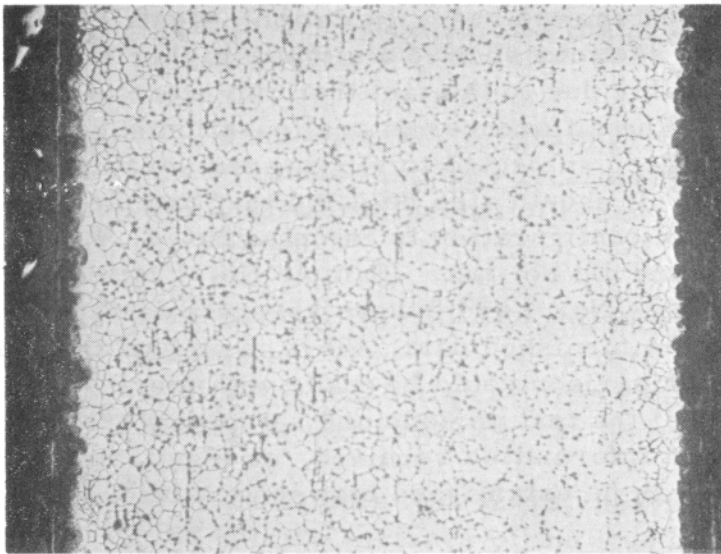
Figure 68

The sample is shown unetched in Figure 67. Oxidation was slightly higher on the inner surface. Figures 68 and 69 show the sample after etching. Sigma phase is present both in stringers and in the grain boundaries.
