Report No. FAA-RD-71-3

TITANIUM FUSELAGE ENVIRONMENTAL CONDITIONS IN POST-CRASH FIRES

Constantine P. Sarkos
National Aviation Facilities Experimental Center
Atlantic City, New Jersey 08405

FINAL REPORT

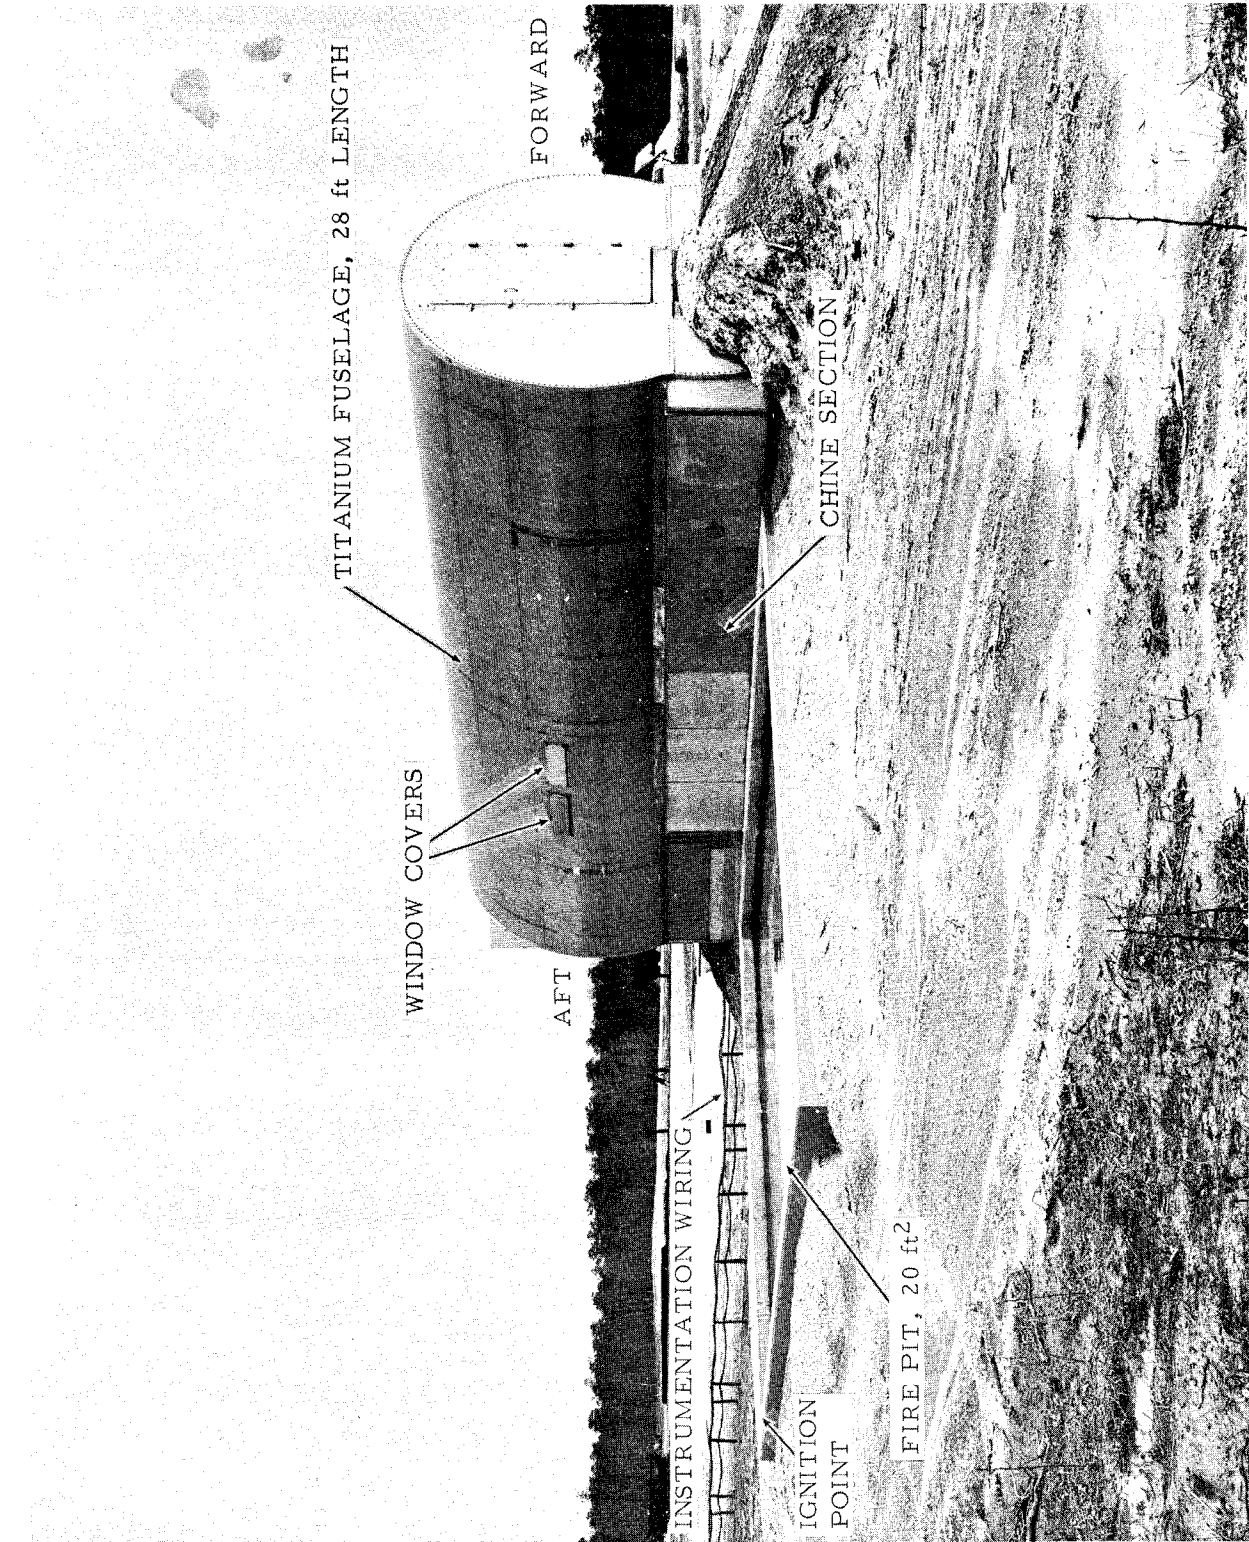
FIGURE 1 - TITANIUM FUSELAGE AND ADJACENT FIRE PIT

The side of the fuselage exposed to the fire presented considerable evidence of flame exposure, as is shown in Figure 9. This is quite a contrast to Figure 1, which shows the same view of the fuselage before the test. The flame pattern was etched on the titanium skin, demonstrating that the fuel flames had been drawn towards the firewhirl at the aft end of the fuselage. Because of the thermal stresses generated during the test, the titanium skin was permanently deformed and had a wrinkled appearance, especially at the areas which experienced the most severe heating. However, this deformation was insignificant in that it did not produce any gaps which could have allowed the fuel flames to come directly in contact with the interior materials within the fuselage. The fuselage skin near the lower aft end developed 12 fractures during the cooling-down period following the extinguishment of the pit fire (Figure 10). The length of tear ranged from 1 to 6 inches. An increase in the cooling of the skin because of the inadvertent application of extinguishing agent appears to have aided, if not caused, the formation of these fractures.

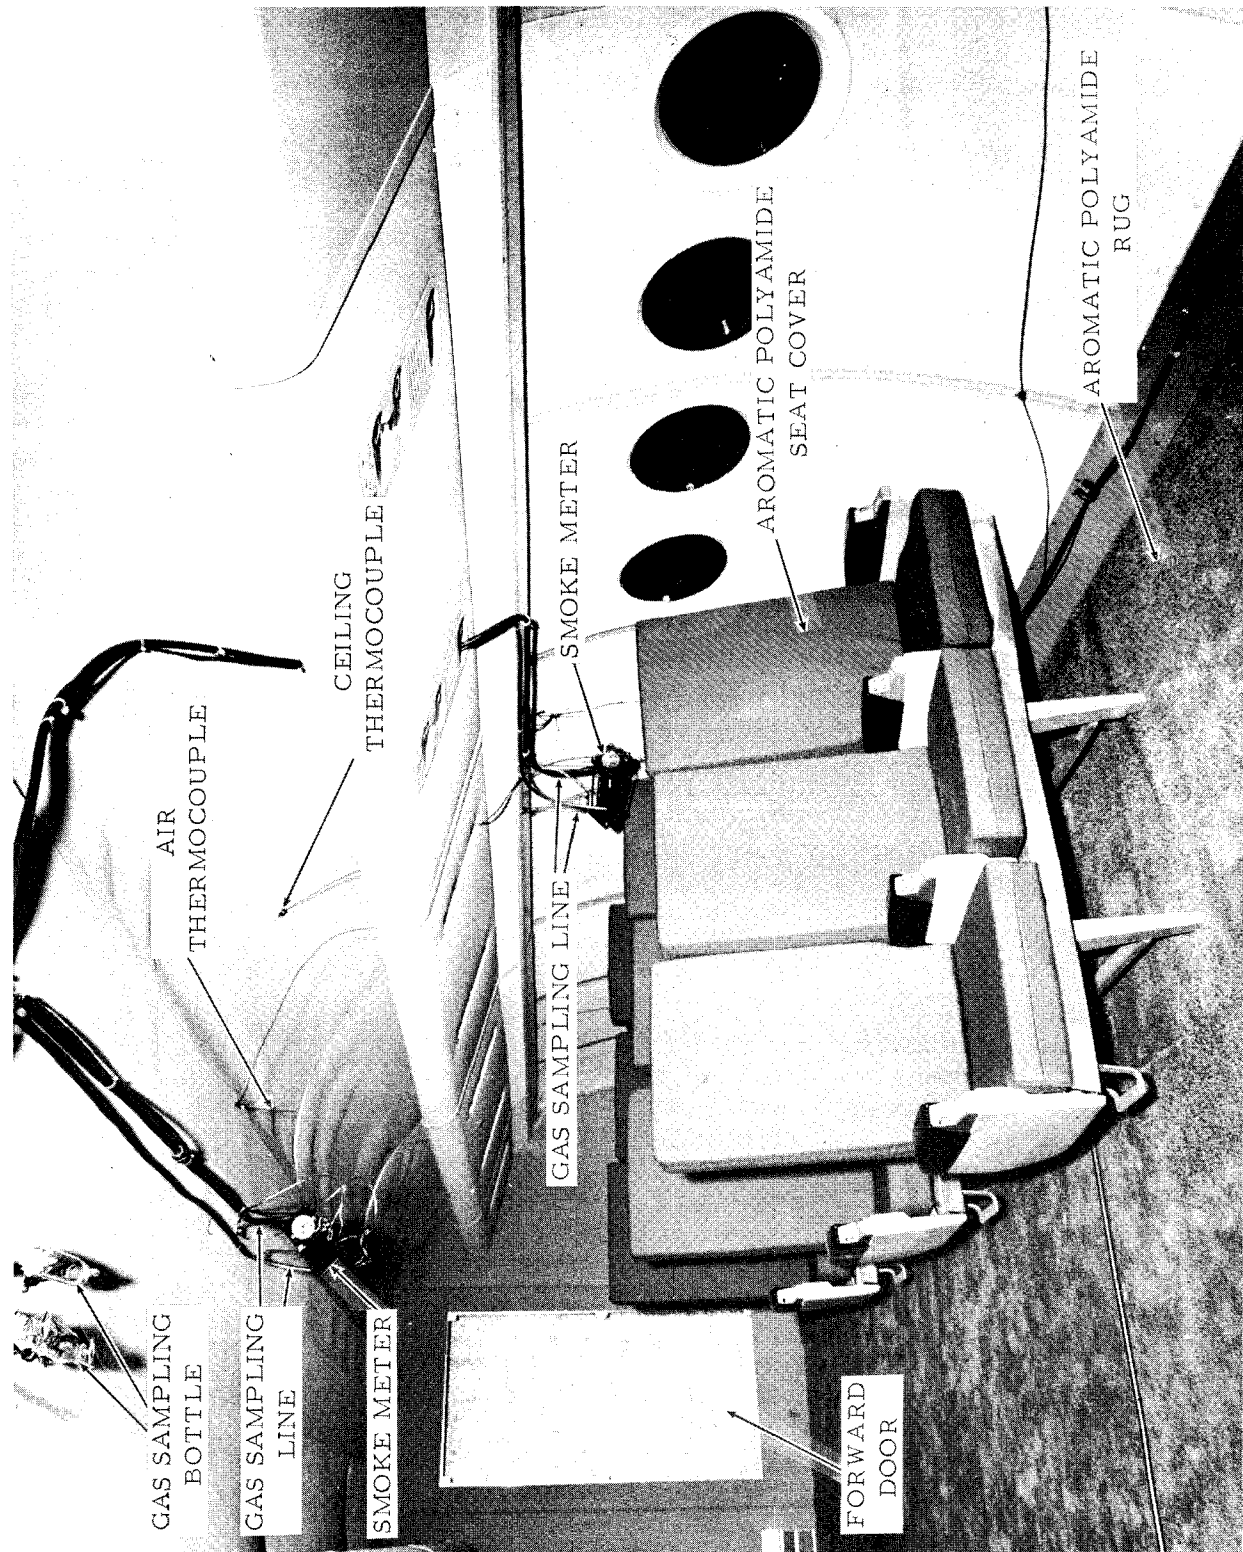
FIGURE 4 - CABIN FURNISHINGS AND INSTRUMENTATION

A view of the cabin after the test is shown in Figure 11, and, when compared with Figure 4, exhibits considerable damage. Note the large amount of foam extinguishing agent accidentally discharged during the initial extinguishment of the floor fire. The hatrack and ceiling damage indicated that the flash fire originated at the aft end of the fuselage (the seats are facing aft) and, as expected, was more severe near the top of the cabin. Molten aluminum, splattered against the seats during the extinguishment of the floor fire, did not ignite the seat upholstery. A closeup of the locality of the floor fire is shown in Figure 12. Sections of the aluminum honeycomb floorboard and the flammable insulation were removed during the fire extinguishment. Special notice should be given to the presence of burn marks in the vicinity of the interior panel interfaces (this will be discussed subsequently in greater detail).

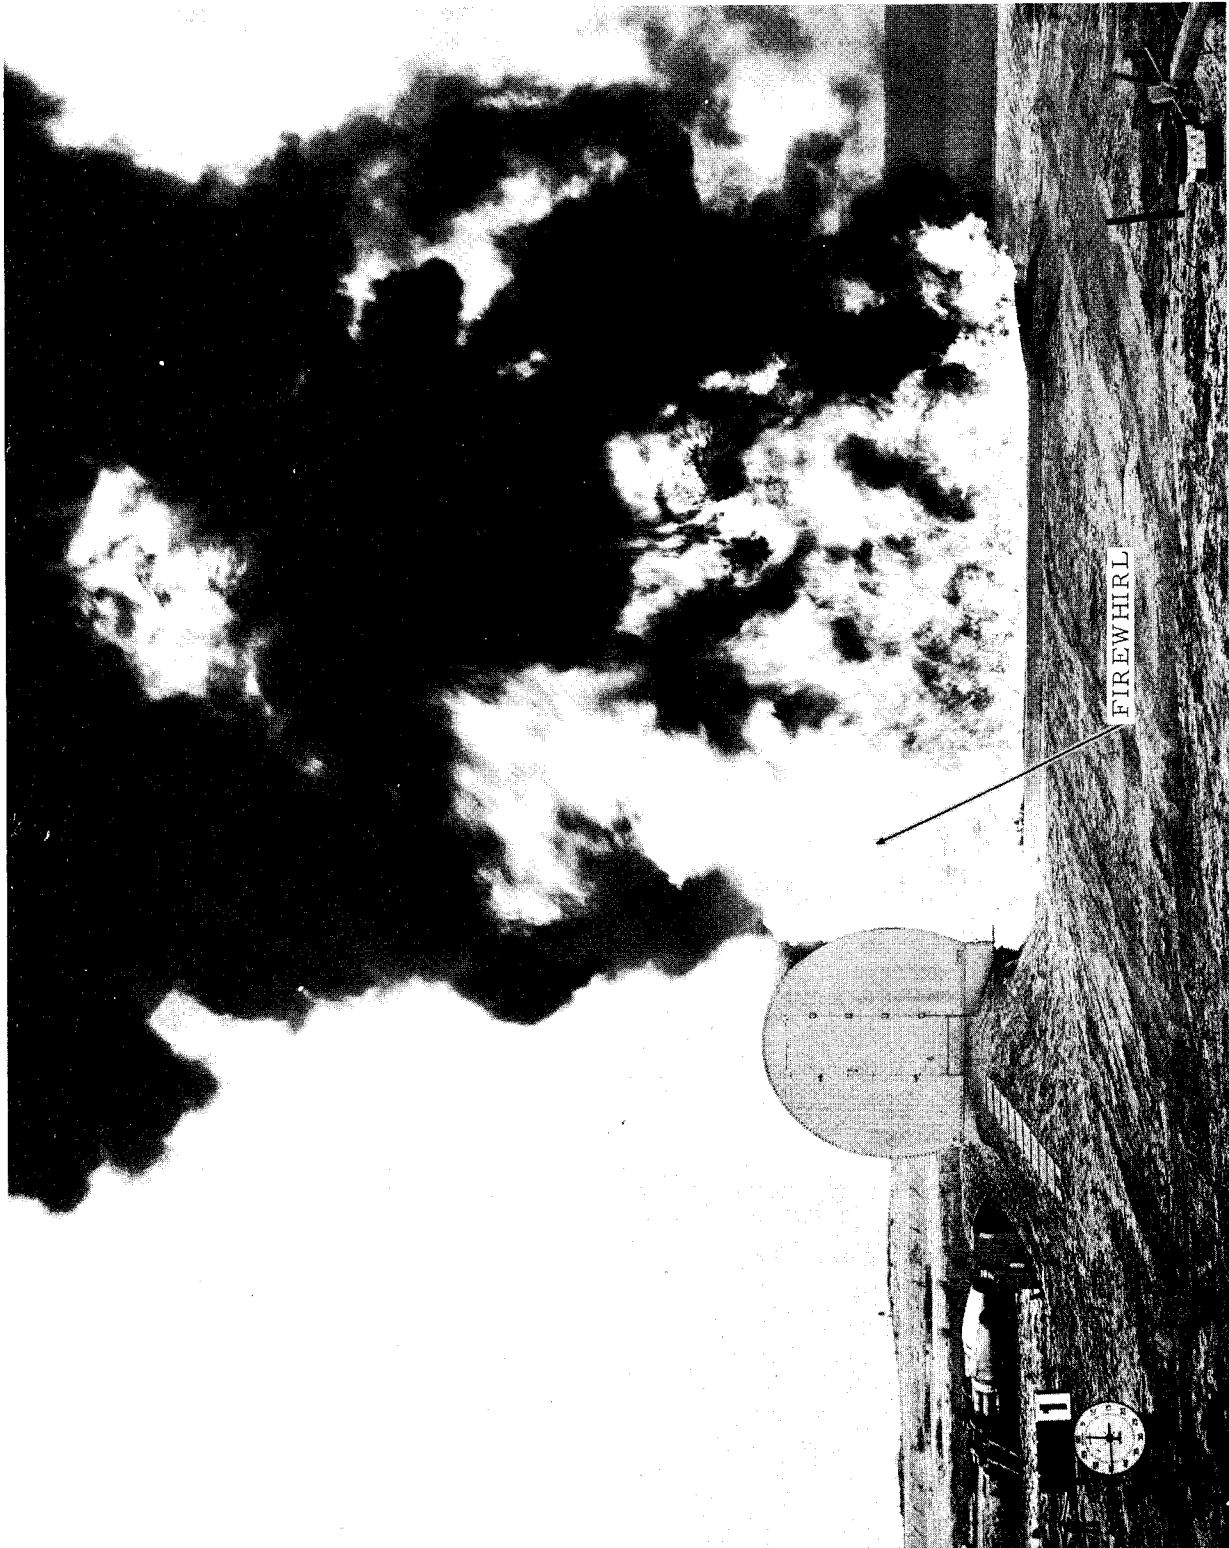
The fuel was ignited with a torch at the outside corner of the fire pit nearest the aft end of the fuselage (Figure 1). In a matter of a few seconds the flames completely engulfed the entire pit. However, the fire did not reach full intensity until about 10-15 seconds after ignition. At about this time, or shortly thereafter, a firewhirl developed adjacent to the fuselage near the aft end. Figure 8 shows the test at 45 seconds after ignition. The firewhirl was displaced away from the fire pit and extended to the aft end of the fuselage. (Some evidence of the low wind velocity is provided in this figure by the vertical column of smoke.) At approximately 80 seconds after ignition, the firewhirl unexpectedly moved to the forward end of the fuselage, remained there for 5-10 seconds, and then shifted back to the aft end where it remained until cessation of the test. A pop was heard at 1 minute 55 seconds after ignition, and was accompanied by a sudden egression of smoke from around the edges of the door. This was then interpreted (and later demonstrated by both data analysis and examination of the test article) as resulting from a flash fire within the fuselage. Twenty seconds later the firemen were signaled to extinguish the pit fire. Complete extinguishment was accomplished by 3 minutes 50 seconds after ignition; however, because of the high cabin temperatures, the fuselage was not entered until a later time. The fuselage gas composition was drawn into the sampling bottles at 5 minutes after ignition. At 15 minutes after ignition the aft door was opened, releasing a considerable amount of smoke from within the fuselage. The interior motion picture camera, which was positioned near the aft door, was removed from the fuselage. Unfortunately, the film was destroyed. A small fire broke out beneath the floor near the aft end of the fuselage at about 27 minutes after ignition and was quickly extinguished with CO₂. Three minutes later ignition recurred, this time resulting in severe flaming, and making it necessary to extinguish the fire with water. (Originally it was decided to only use CO₂ for any interior fires

FIGURE 8 - TITANIUM FUSELAGE FIRE TEST AT 45 SECONDS
AFTER IGNITION

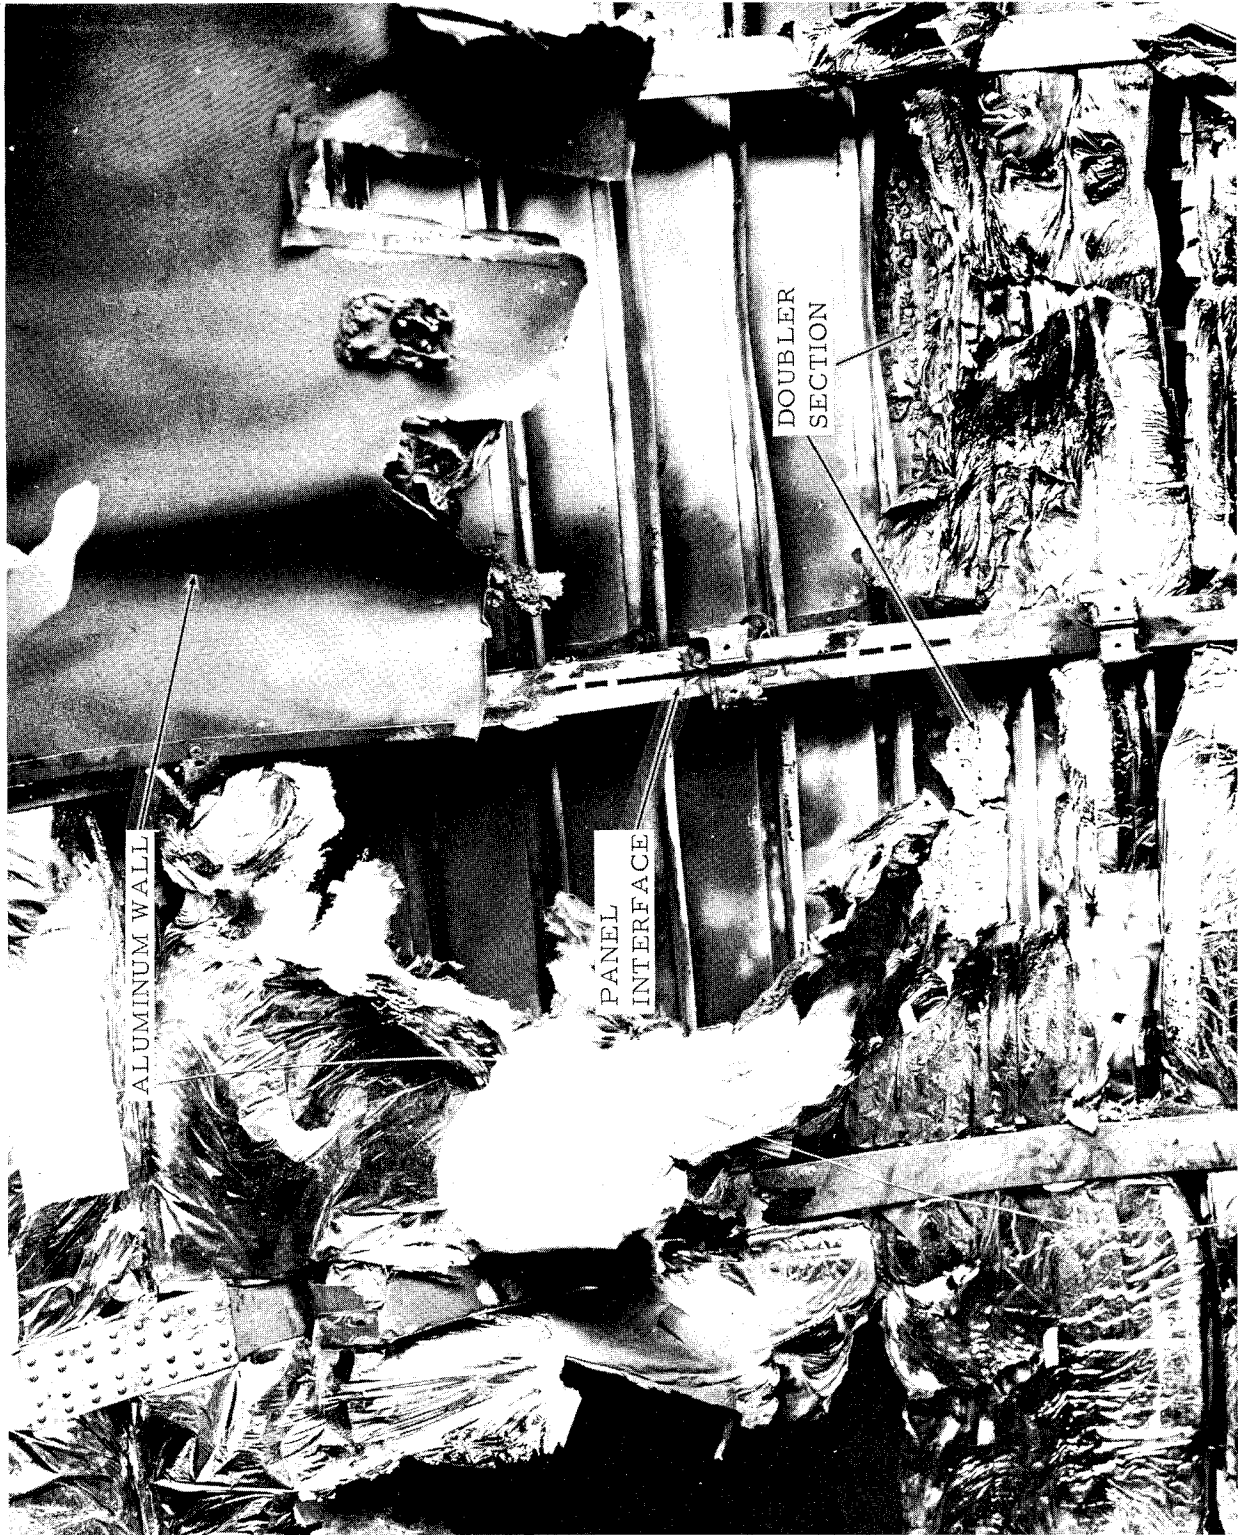
The next step in the examination of the test article was to remove the interior panels. Figure 17 shows the same section near the aft end as Figure 16, but with the interior panels removed. It was evident that severe burning of the RTV sealant and fiberglass (binder) insulation had occurred during the test. The degree of fire damage followed four trends: it was most severe (1) toward the aft end, (2) toward the cabin floor, (3) in the vicinity (especially above) of the RTV-covered doubler sections, and (4) toward the interior panel interfaces. The first two trends are clearly discernible in Figure 17, while the third trend is better illustrated by the closeup shown in Figure 18. Immediately above the RTV-covered doubler section the insulation was burned away, especially near the panel interface where the oxygen necessary for combustion could be obtained from the cabin air. It appears as if the RTV ignited first and acted as an ignition source for the burning of the insulation. Another closeup better displays the fourth trend (Figure 19). Although it is not clearly distinguishable in this black and white photograph, the insulation adjacent to the center former was unburned, while the insulation near the outer formers (panel interfaces) was severely damaged. Also, the RTV used on the formers as an adhesive was burned off the outer former, but that attached to the center former was unscathed. Clearly, the combustion occurred at the panel interfaces where oxygen was readily accessible from the cabin air.

FIGURE 18 - BURNED INSULATION ABOVE DOUBLER SECTION

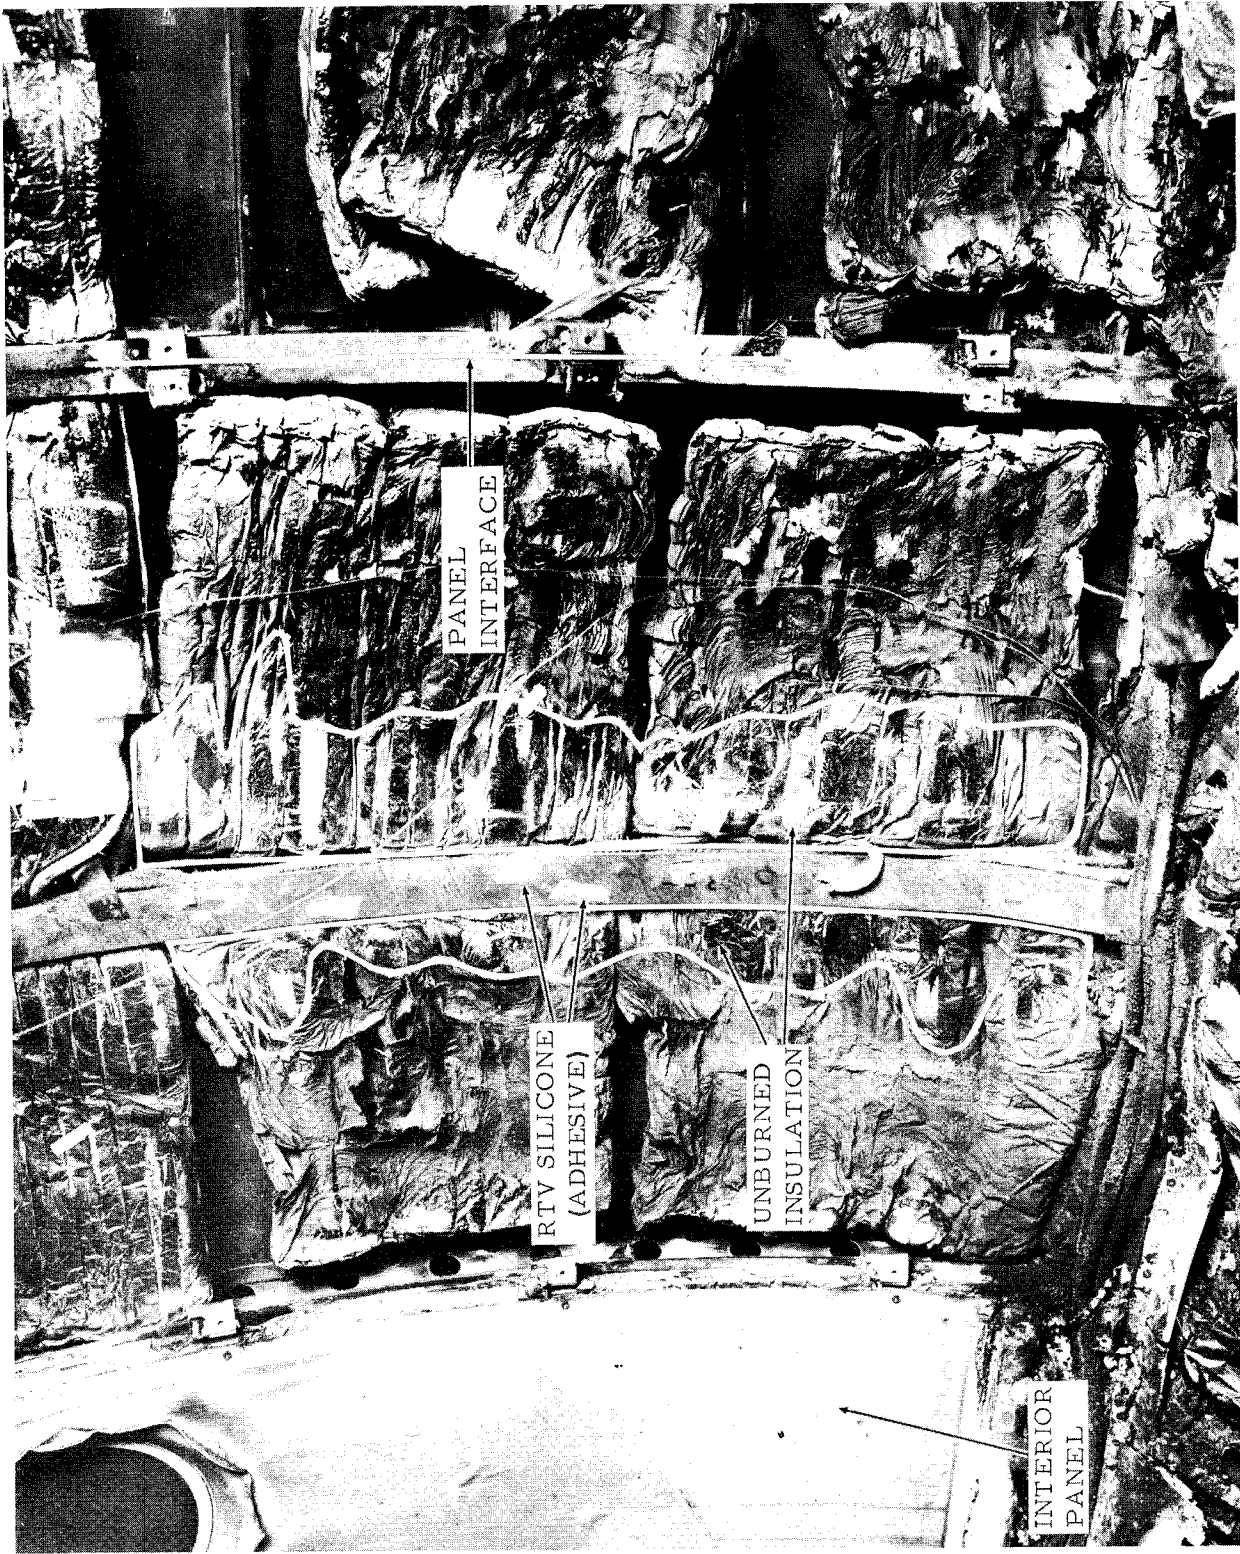
FIGURE 19 - BURNED INSULATION NEAR INTERIOR PANEL INTERFACES
