# Federal Register

**Airworthiness Directives; McDonnell  
Douglas Model DC-9-80 and MD-90-30  
Series Airplanes and Model MD-88  
Airplanes; Final Rule**

**Airworthiness Directives; McDonnell Douglas Model DC-9-80 and MD-90-30 Series Airplanes, and Model MD-88 Airplanes**

**SUMMARY:** This amendment adopts a new airworthiness directive (AD), applicable to certain McDonnell Douglas Model DC-9-80 and MD-90-30 series airplanes, and Model MD-88 airplanes, that requires a determination be made of whether, and at what locations, metallized polyethyleneterephthalate (MPET) insulation blankets are installed, and replacement of MPET insulation blankets with new insulation blankets. This amendment is prompted by reports of in-flight and ground fires on certain airplanes manufactured with insulation blankets covered with MPET, which may contribute to the spread of a fire when ignition occurs from small ignition sources such as electrical arcing or sparking. The actions specified by this AD are intended to ensure that insulation blankets constructed of MPET are removed from the fuselage. Such insulation blankets could propagate a small fire that is the result of an otherwise harmless elect

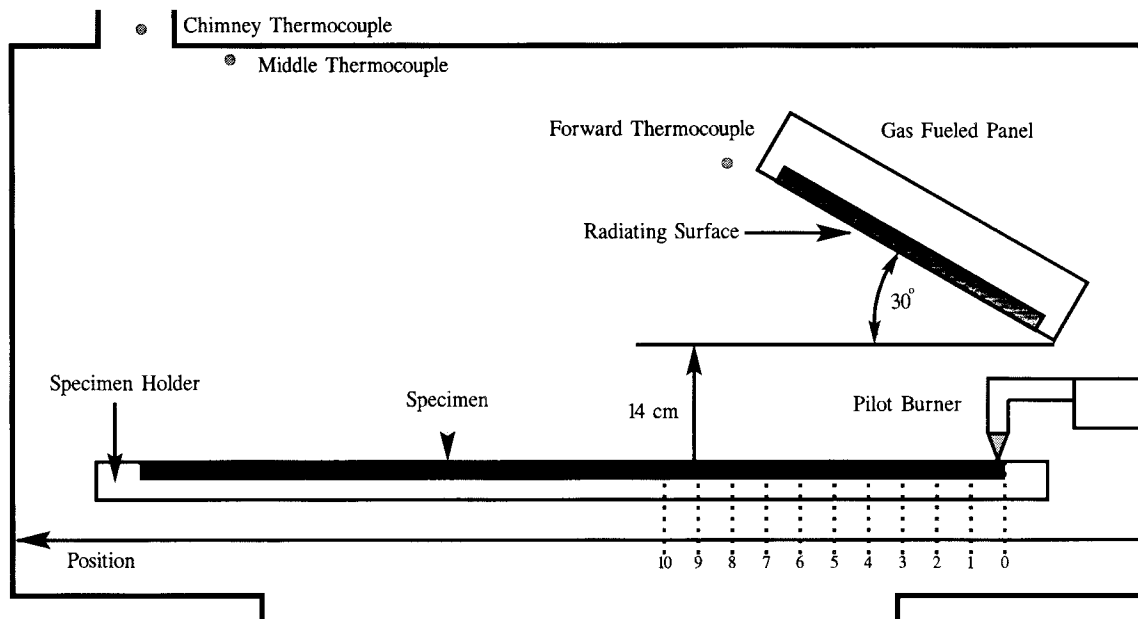
Figure 1.

(b) *Test Apparatus* (as schematically shown in figure 1).

(2) *Radiant Heat Source.* The radiant heat energy source will be a panel of porous refractory material mounted in a cast iron frame, with a radiation surface of 12 by 18 inches (305 by 457mm). It shall be capable of operating at temperatures up to 1500°F (816°C (Figure 1).

(ii) Radiant Panel Placement. The panel will be mounted in the chamber at 30 degrees to the horizontal specimen plane.

(1) During burner application, no flaming is allowed to propagate more than 2 inches (50.8mm) along the sample (to the left in figure 1) of the centerline of the flame.

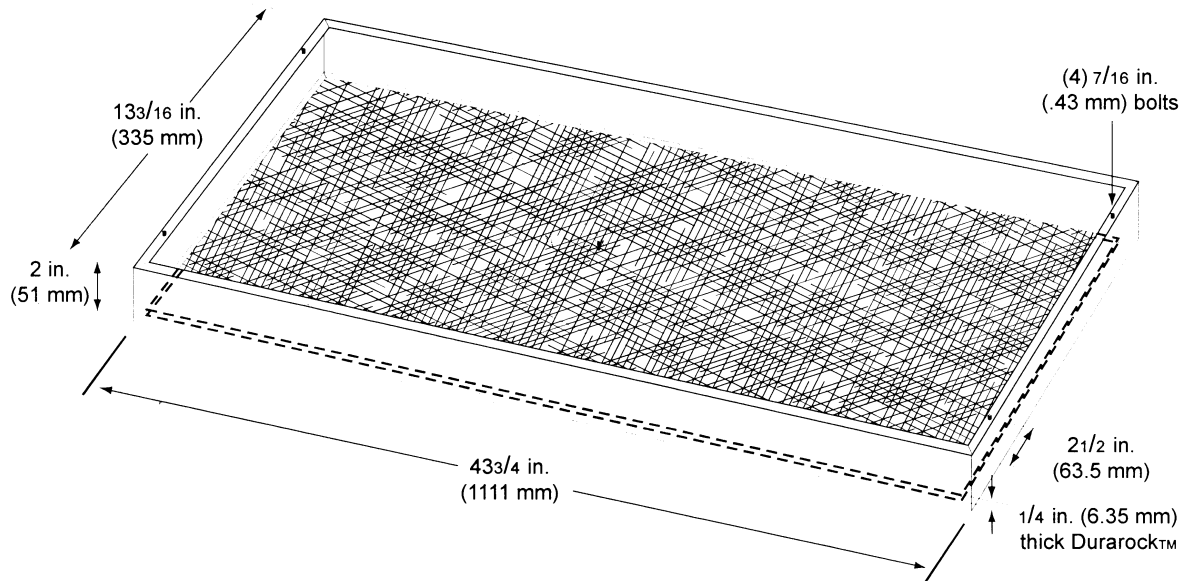
Figure 2: Sliding Platform

(19.1mm) lip that extends around the bottom of the platform base. It is suggested that the shortest piece be placed at the end furthest from the radiant panel (figure 2). A  $\frac{1}{2}$  inch (13mm) piece of Kaowool™ board or other high temperature material measuring  $4\frac{1}{2}$  by  $8\frac{1}{4}$  inches (1054 by 210mm) will be attached to the back side of the platform. This board will serve as a heat retainer and will protect the test specimen from excessive preheating. The height of this board must not be too high such that it will impede the sliding platform movement (in and out) of the test chamber.

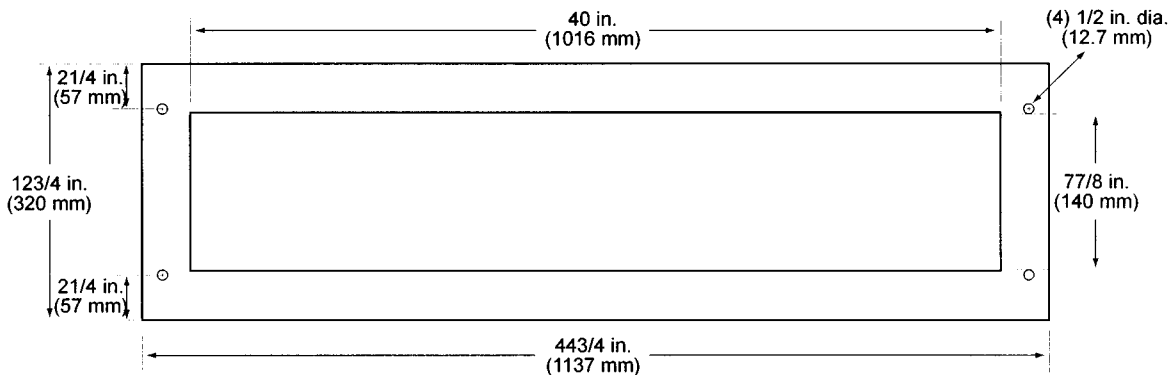
Figure 3: Stainless Steel Retaining Frame

(ii) The test specimen will be placed horizontally on the non-combustible base. A stainless steel retaining frame (AISI Type 300 UNA-NO8330), or equivalent, having a thickness of 0.078 inches (1.98mm) and

overall dimensions of  $44\frac{3}{4}$  by  $12\frac{3}{4}$  inches (1137 by 320mm) with a specimen opening of 40 by  $7\frac{7}{8}$  (1016 by 140mm) will be placed on top of the test specimen. The retaining frame will have two  $\frac{1}{2}$  inch (12.7mm) holes

drilled at each end for positioning the frame to the two stud bolts at each end of the sliding platform (figure 3).

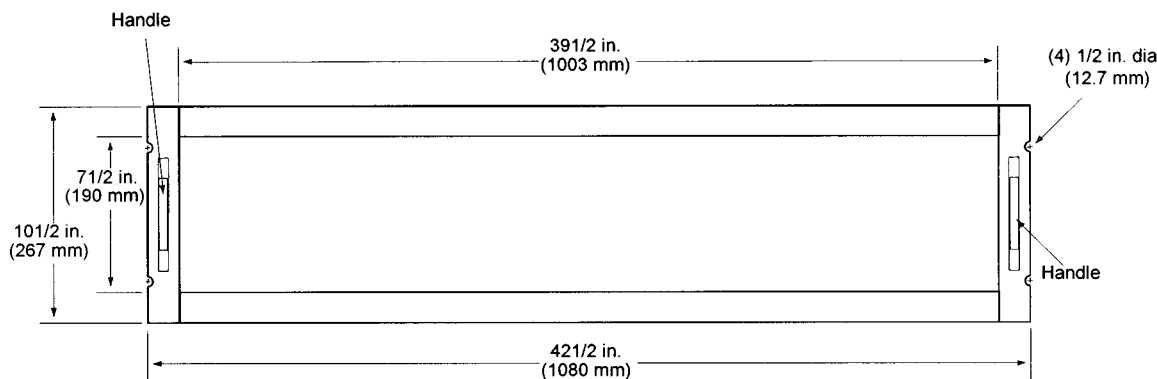
(iii) A securing frame (acting as a clamping mechanism) constructed of mild steel will be placed over the test specimen. The securing frame overall dimensions are  $42\frac{1}{2}$  by  $10\frac{1}{2}$  inches (1080 by 267mm) with a specimen opening of  $39\frac{1}{2}$  by  $7\frac{1}{2}$  inches (1003 by 190mm). Hence, the exposed area of test specimen exposed to the radiant panel is  $39\frac{1}{4}$  by  $7\frac{1}{4}$  inches (996 by 184mm). See figure 4. It is not necessary to physically fasten the securing frame over the test specimen due to the weight of the frame itself.

Figure 4: Angle Iron (1.5x1.5) Securing Frame  
\*NOTE: All Seams Welded

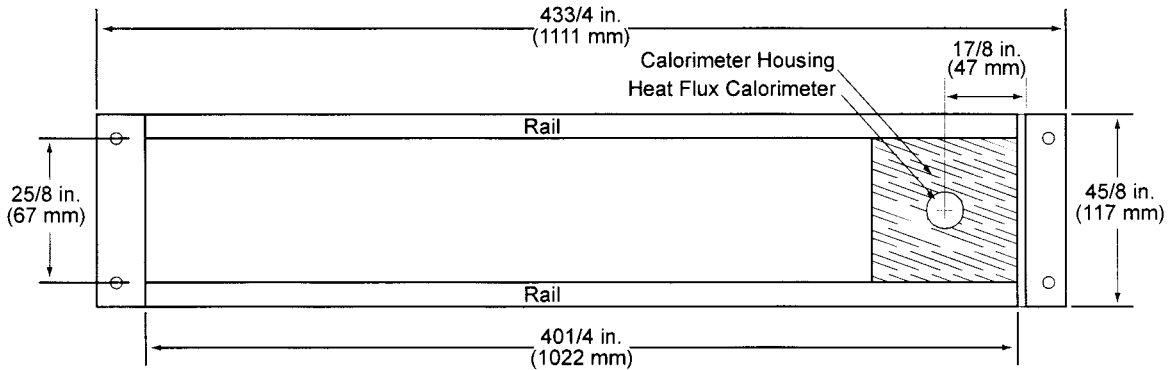
Figure 5: Calorimeter Rail

(8) *Calorimeter Fixture.* With the sliding platform pulled out of the chamber, install a 2-rail fixture that has a travel range of 40 1/4 inches (1022mm) over the sliding platform. The dimension between the 2 rails is 2 11/16 inches (68mm). The rail fixture is screwed into the sliding panel, such that it is always directly under the geometric center of the radiant panel (figure 4). Push the platform into the chamber and insert the calorimeter. The calorimeter, which is mounted in an insulated housing, fits in the rail opening but has enough clearance such that it may be moved along the rail for heat flux readings. The top surface of the calorimeter must be level with the rails.

(1) With the sliding platform out of the chamber, install the rail fixture. Push the platform back into the chamber, install the calorimeter (in its housing), and move the calorimeter to the "zero" position (figure 5). Close the bottom door located below the

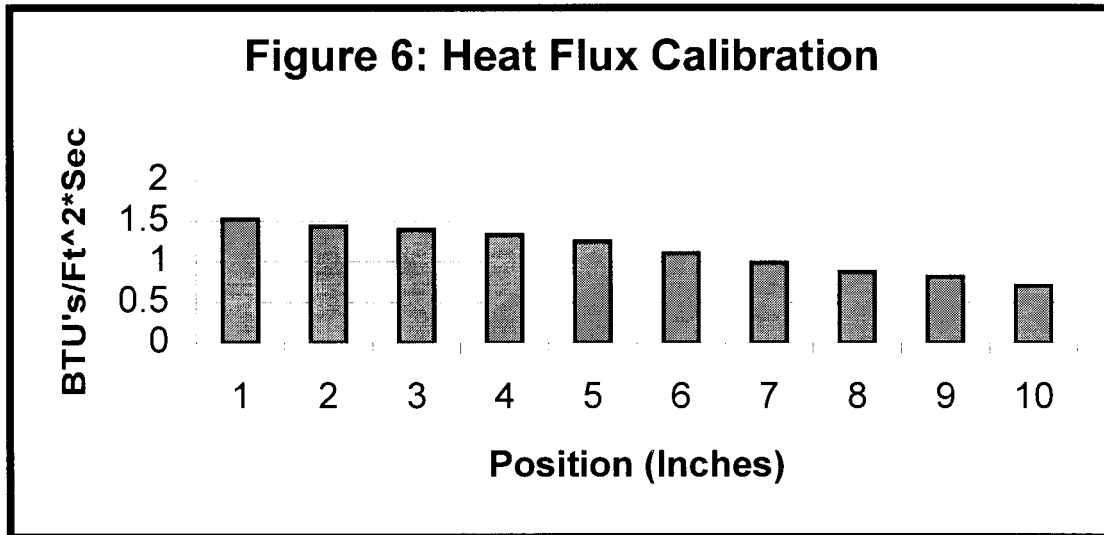
(3) After steady-state conditions have been reached, move the calorimeter 2 inches (51mm) from the "zero" position and record

the heat flux. Allow a minimum of 30 seconds at each position for the calorimeter

to stabilize. Record at least 10 positions. (Figure 6 depicts a calibration profile.)

(4) It is not necessary to run a full heat flux calibration (minimum of 10 positions) each time the chamber is powered on. It is required that a heat flux measurement be taken at the "zero" position at the start of the test period (e.g., each morning) to ensure that the 1.5 BTU/ft<sup>2</sup>-second (1.9 Watts/cm<sup>2</sup>) requirement be met. A full calibration should be run periodically.
