DOT/FAA/CT-92/6

Aircraft Cabin Water Spray Disbenefits Study

October 1993

Final Report

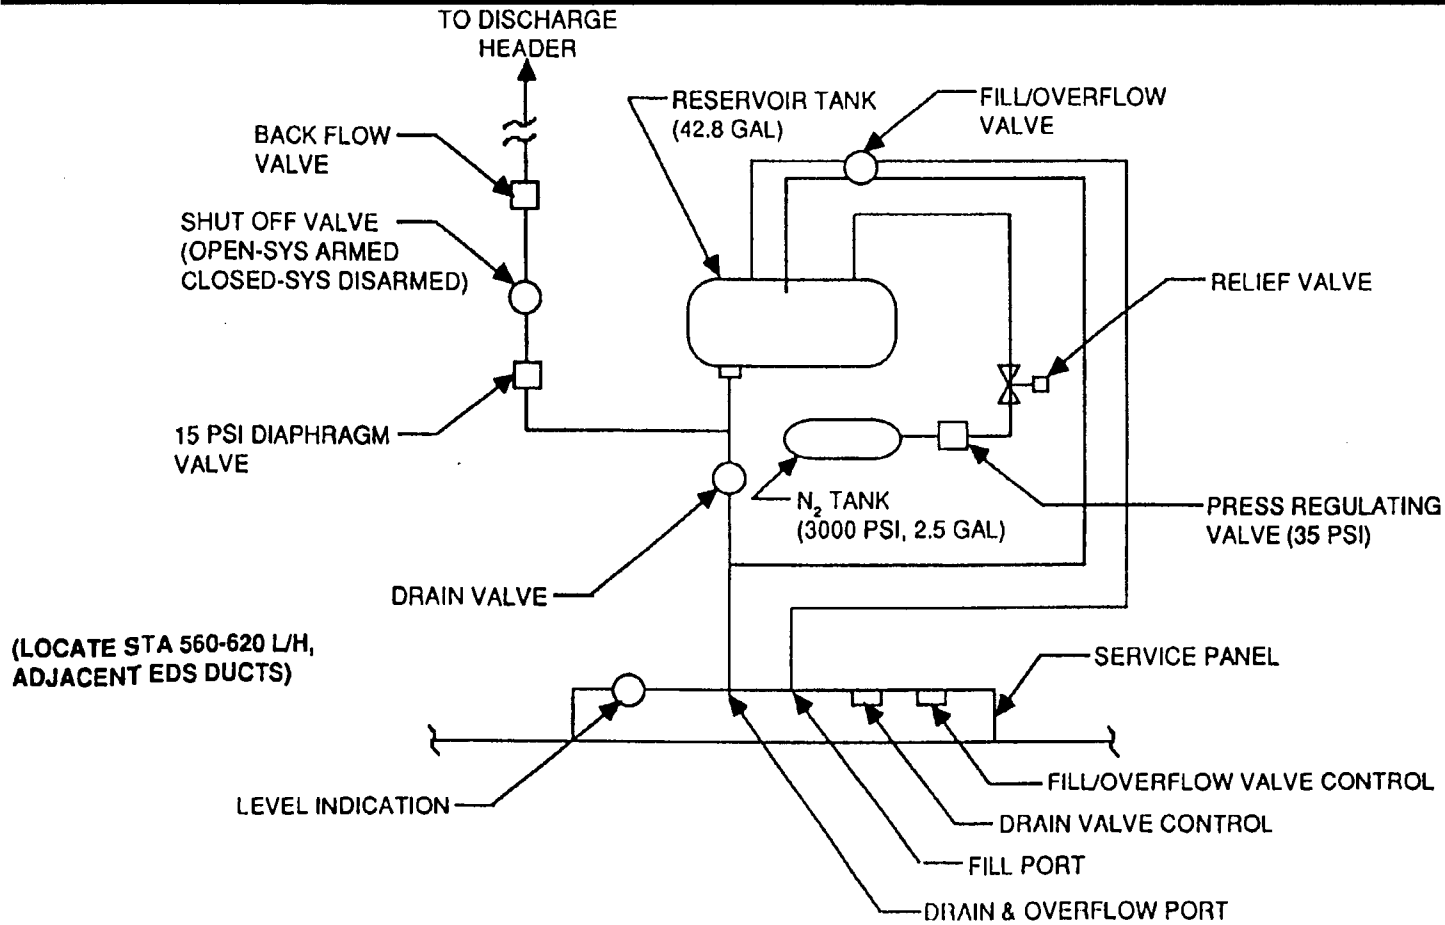
SCHEMATIC FWD RESERVOIR TANK

MODEL 761-650

- Two non-metallic water reservoir tanks (similar to existing potable water tanks) of approximately 40 gallons each, in body section 43 and 46, respectively.
- Water tank maintenance panel adjacent each water tank (see Figure 4 and 5).
- 3000 psi nitrogen bottle with squib activated pneumatic valve, adjacent each water tank.
- Water distribution tubing (see figures 2 and 3).
- Four external fire hose connections through the fuselage lower lobe, two forward and two aft of the wing box.

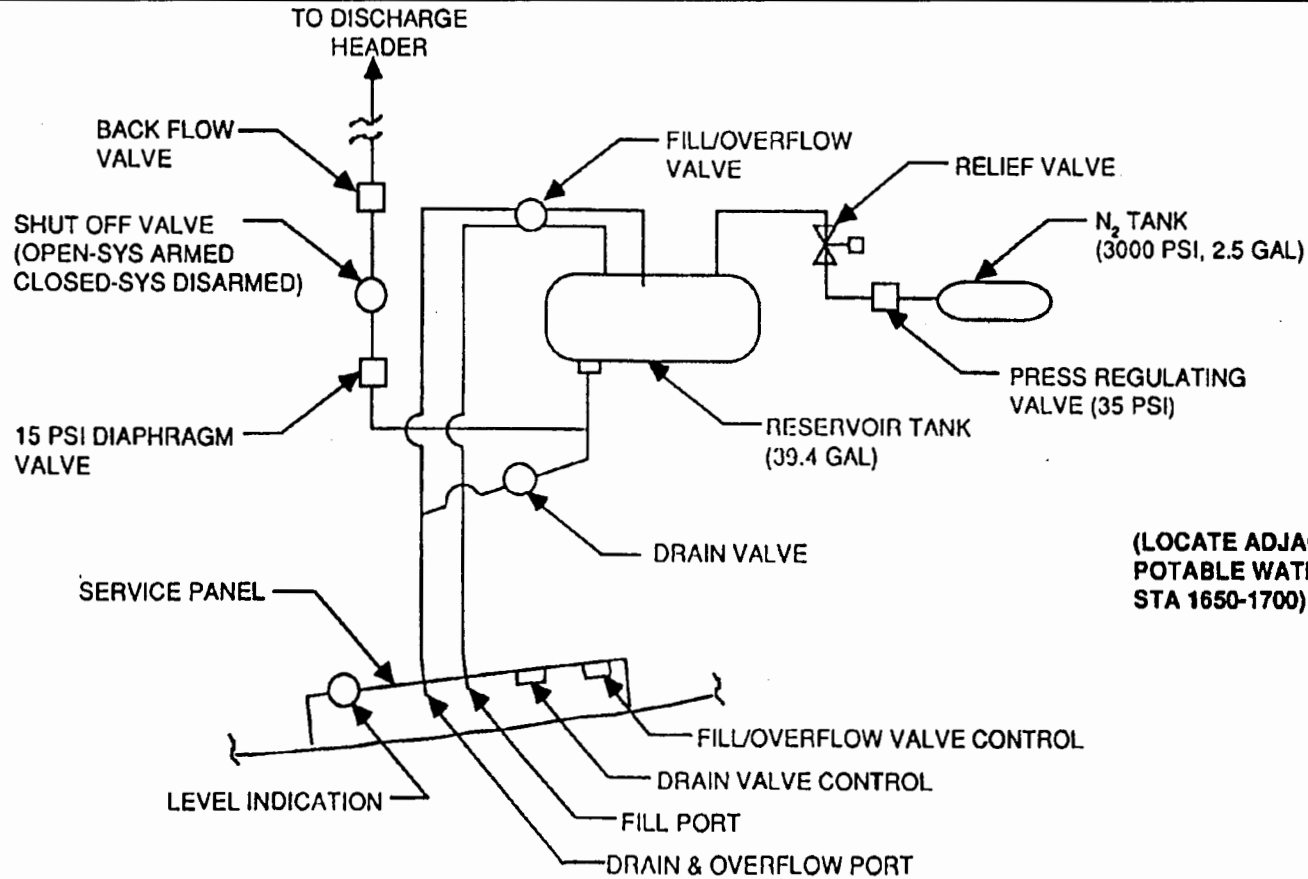
Figure 5

SCHEMATIC AFT RESERVOIR TANK

MODEL 761-650
