# NATIONAL TRANSPORTATION SAFETY BOARD

## SPECIAL STUDY

U.S. AIR CARRIER ACCIDENTS  
INVOLVING FIRE  
1965 THROUGH 1974 AND  
FACTORS AFFECTING THE STATISTICS

REPORT NUMBER: NTSB-AAS-77-1

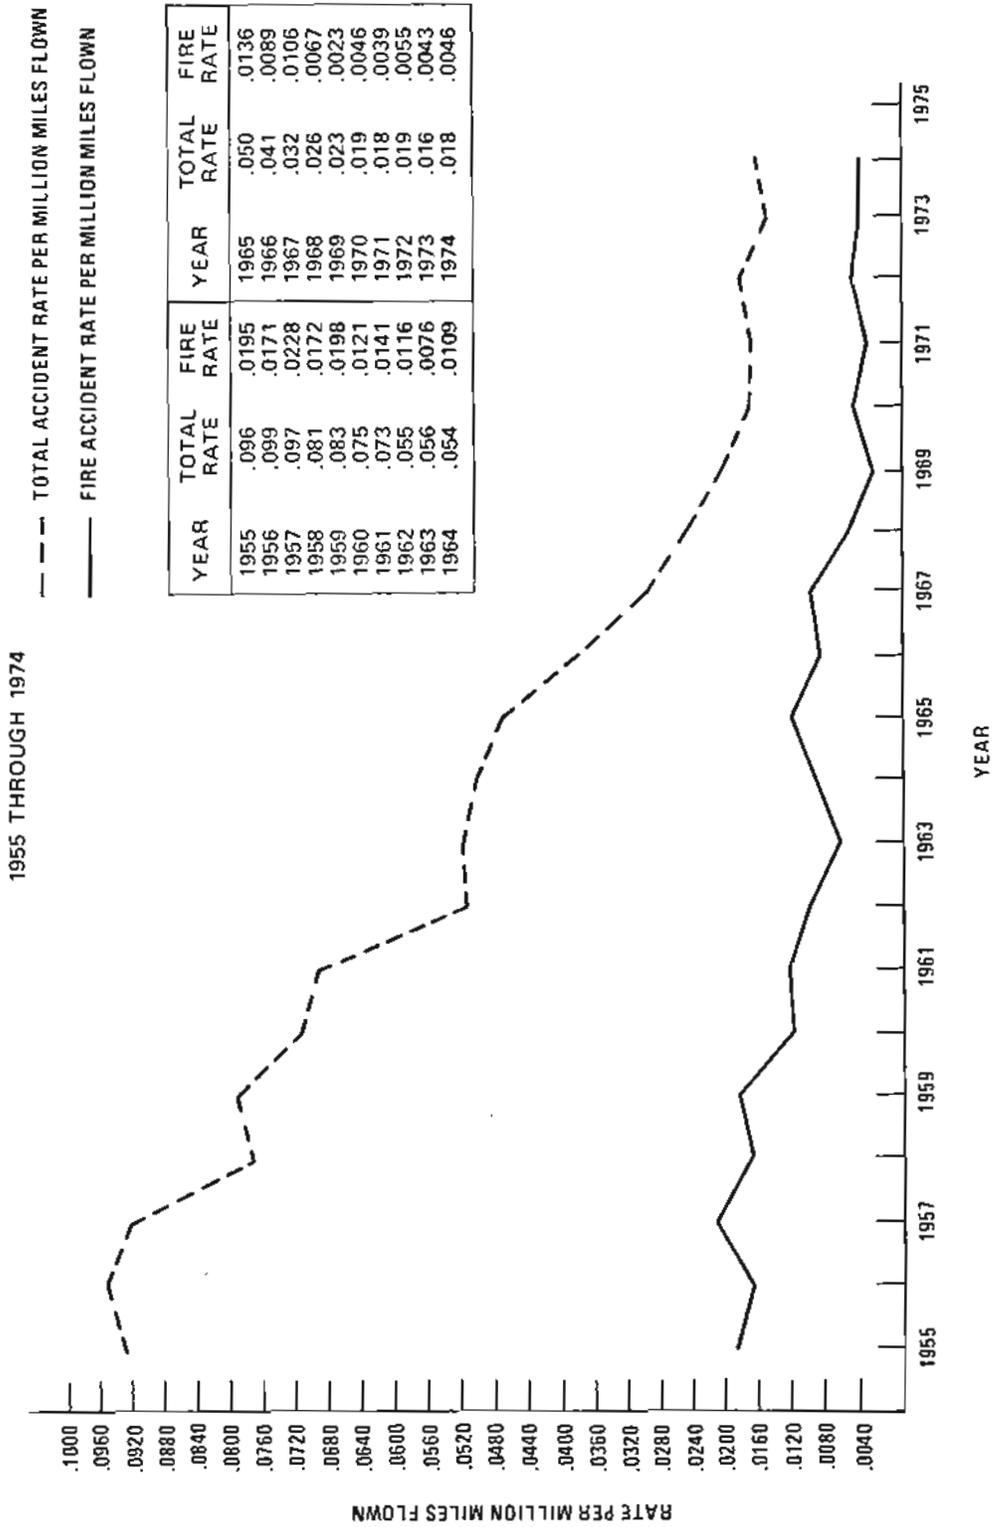
FIGURE 1  
**U.S. CERTIFICATED ROUTE AIR CARRIERS**  
**(ALL OPERATIONS)**  
 1955 THROUGH 1974

U.S. certificated air carriers experienced a tremendous growth during the 20 years covered by the two studies. The total aircraft-miles flown by U. S. certificated air carriers in all operations grew from 819,581,000 in 1955 to 2,385,000,000 in 1974 (a three-fold increase). Similarly, the number of passenger-miles flown by U. S. air carriers (scheduled passenger service) grew from 25,152,000,000 in 1955 to 173,350,000,000 in 1974 (a seven-fold increase). During the same period, the number of passengers carried by the U. S. air carriers in domestic and international passenger operations grew from 41,444,000 in 1955 to 207,449,000 in 1974 (a five-fold increase). This period of

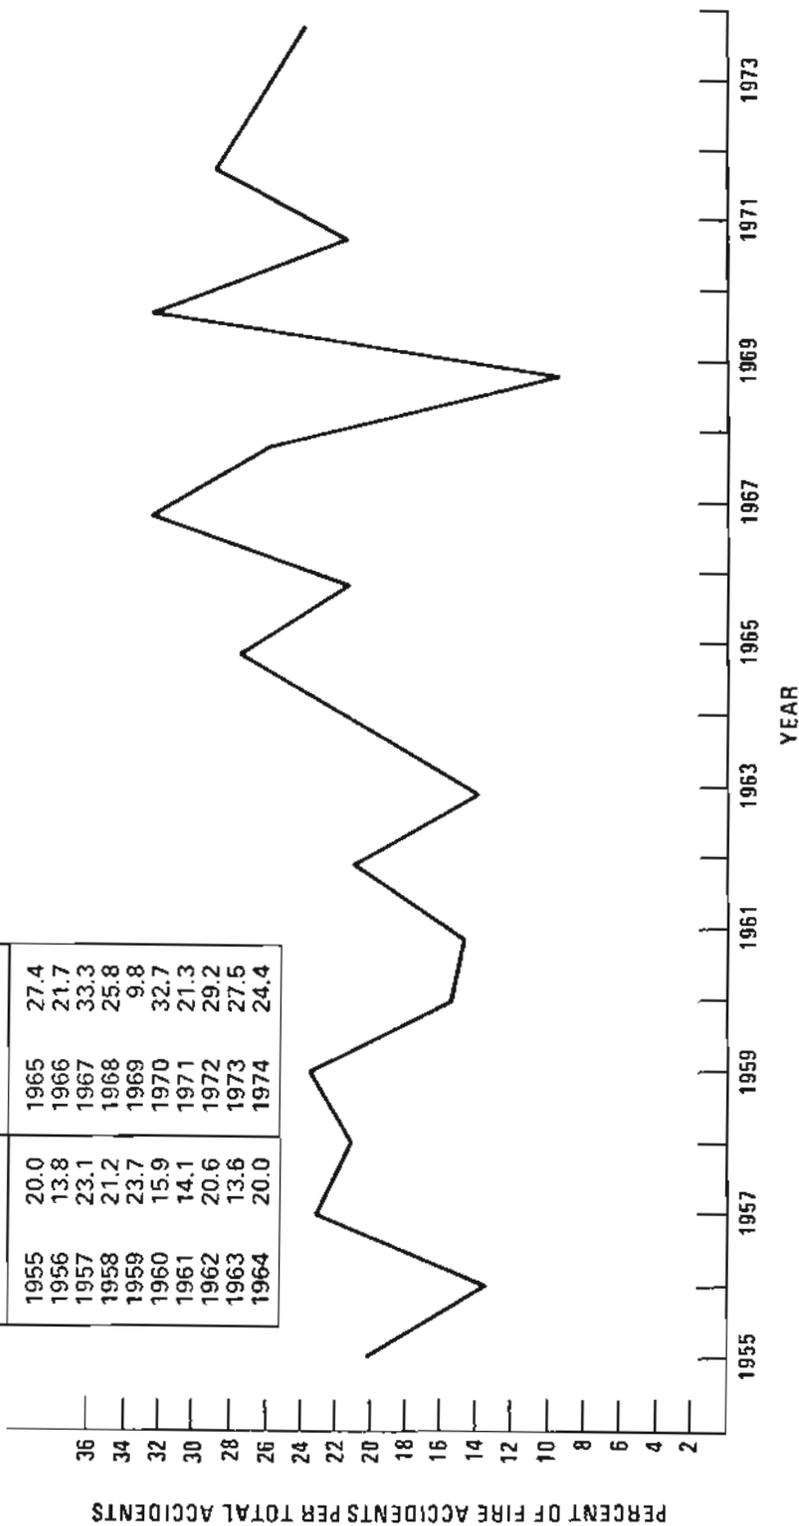
FIGURE 3

**RATIO OF FIRE ACCIDENTS TO TOTAL ACCIDENTS**  
**U.S. CERTIFICATED ROUTE AIR CARRIERS**  
**(ALL OPERATIONS)**  
 1955 THROUGH 1974

YEAR	%	YEAR	%
1955	20.0	1965	27.4
1956	13.8	1966	21.7
1957	23.1	1967	33.3
1958	21.2	1968	25.8
1959	23.7	1969	9.8
1960	15.9	1970	32.7
1961	14.1	1971	21.3
1962	20.6	1972	29.2
1963	13.6	1973	27.5
1964	20.0	1974	24.4

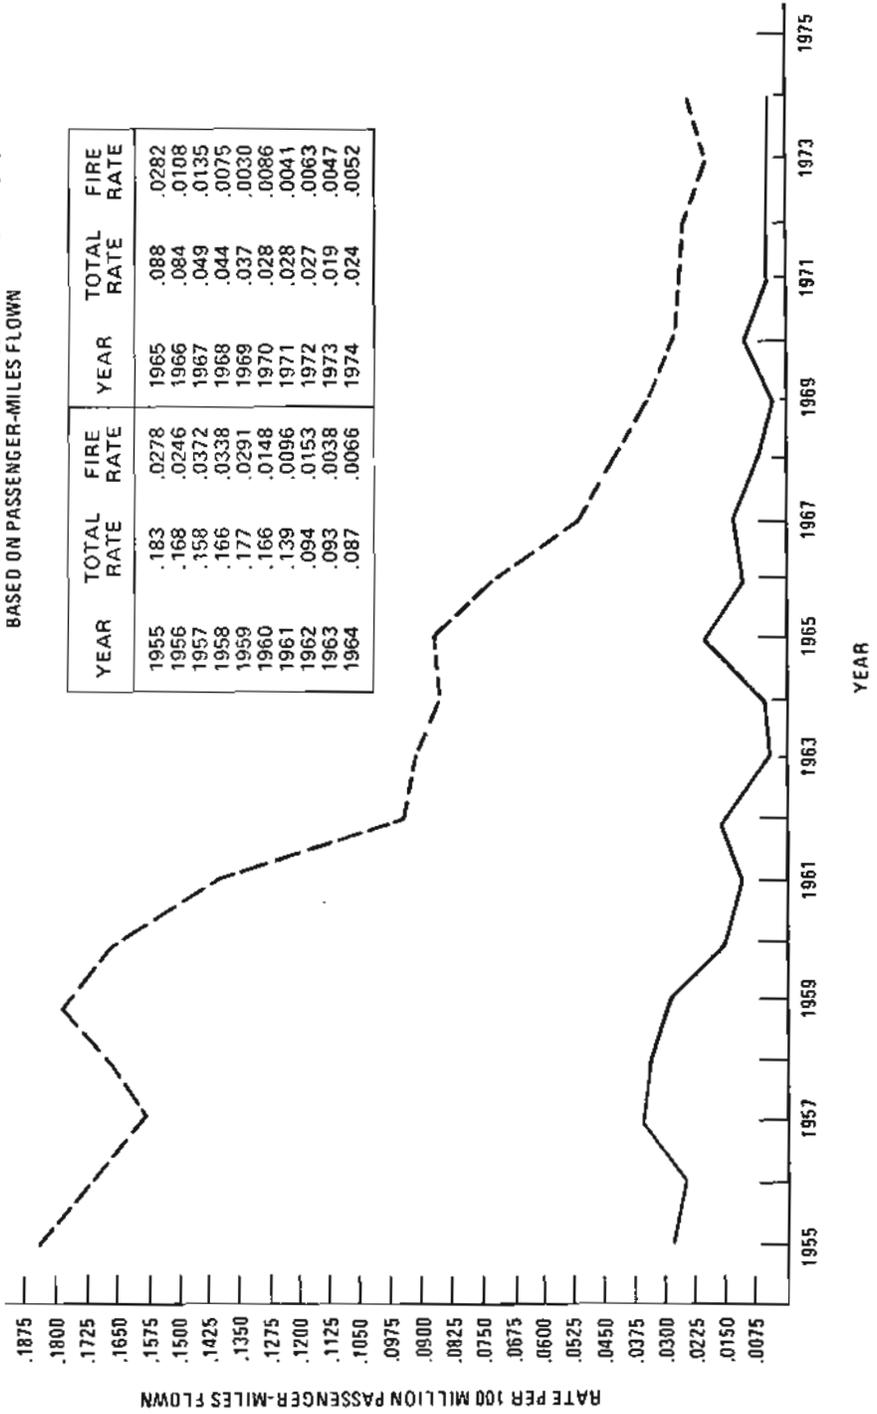
FIGURE 4  
**U.S. CERTIFICATED ROUTE AIR CARRIERS  
 SCHEDULED DOMESTIC AND INTERNATIONAL PASSENGER OPERATIONS**  
 1955 THROUGH 1974

--- TOTAL ACCIDENT RATE FOR PASSENGER OPERATIONS -  
 BASED ON PASSENGER-MILES FLOW

— FIRE ACCIDENT RATE FOR PASSENGER OPERATIONS -  
 BASED ON PASSENGER-MILES FLOW

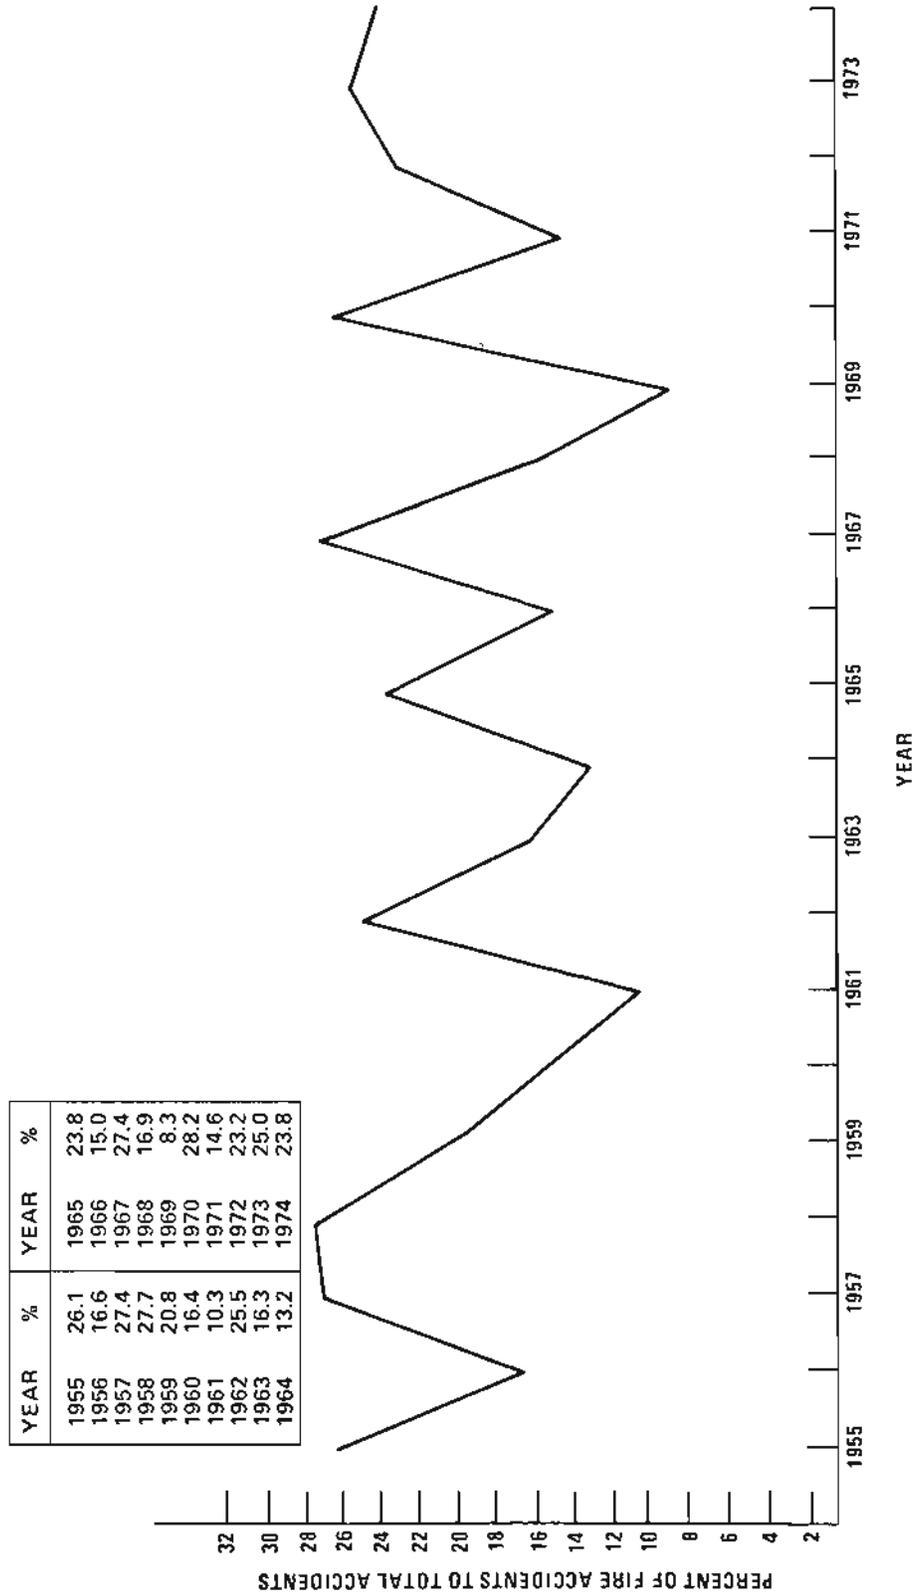
FIGURE 6  
**RATIO OF FIRE ACCIDENTS TO TOTAL ACCIDENTS**  
**U.S. CERTIFICATED ROUTE AIR CARRIERS**  
**IN DOMESTIC AND INTERNATIONAL PASSENGER OPERATIONS**

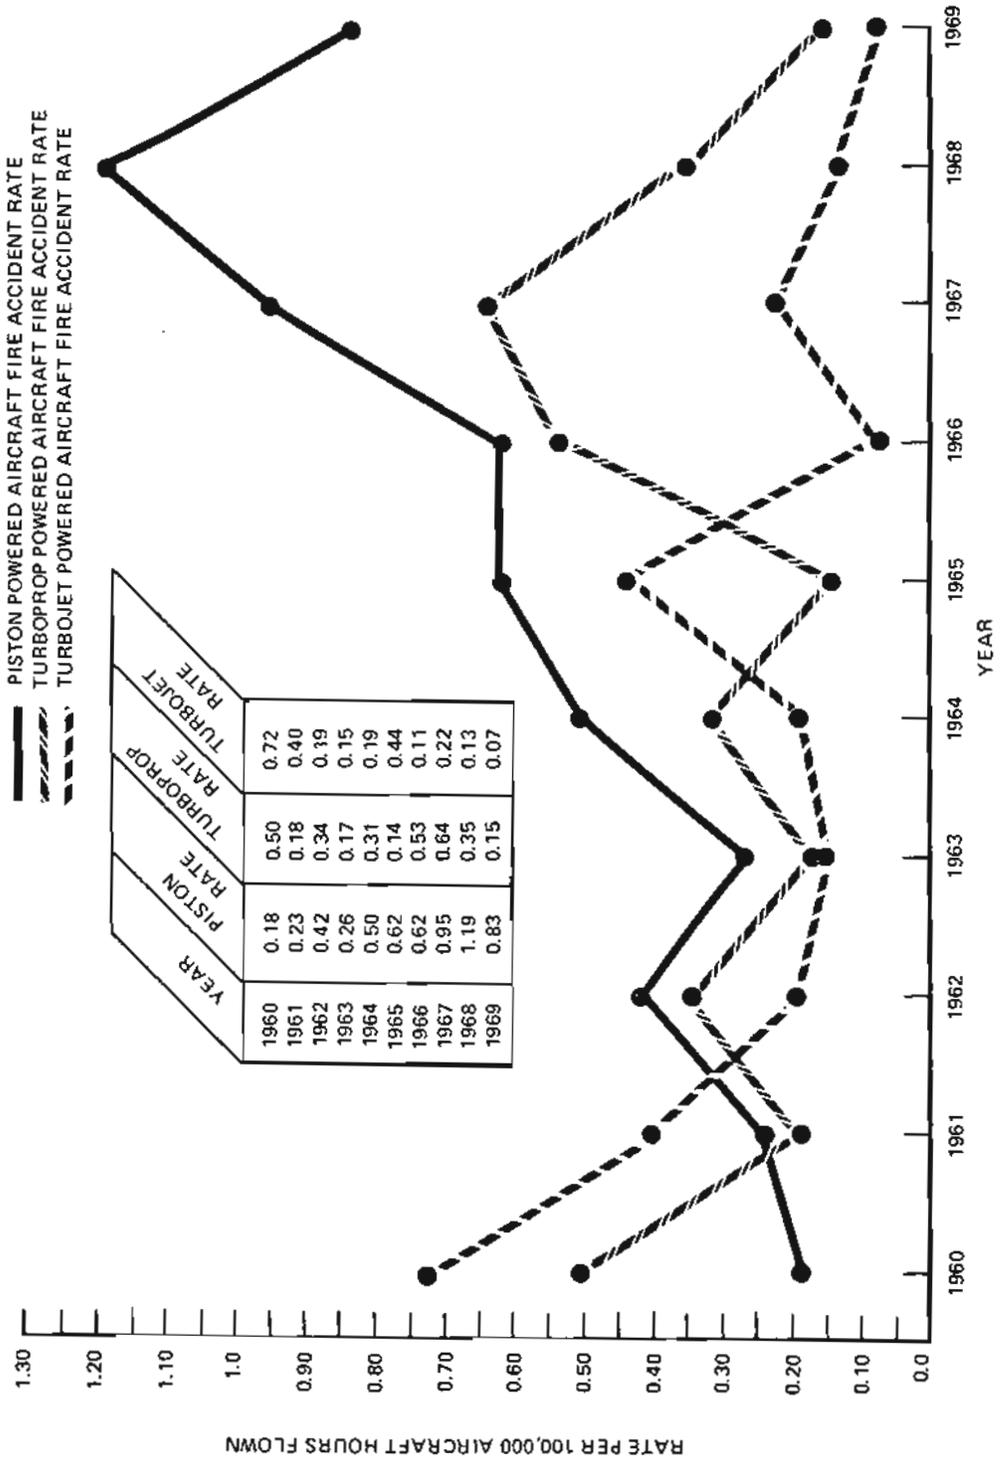
FIGURE 9  
**FIRE—INVOLVED ACCIDENT RATE BY TYPE OF ENGINE POWER**  
 U.S. CERTIFICATED ROUTE AIR CARRIERS  
 (ALL OPERATIONS) 1960 THROUGH 1969

For comparison, the fire-involved air carrier accident rates by type of engine power are plotted in Figure 9. The quantum jump in the piston-powered accident rate is explained by the fact that, while these aircraft were being phased out, a few fire-involved accidents affected significantly the accident rate because of the small number of operations.

The turbojet aircraft operated by U. S. carriers generally use kerosene-type fuel, while the piston aircraft use gasoline exclusively. It has been well documented that the overall fire hazards for kerosene-type fuel are less than for the more volatile gasoline fuels. <sup>1/</sup> The kerosene-type fuels have been found to be less hazardous than gasoline in ground handling and refueling situations. Moreover, the kerosene-type fuel is less likely to produce a flammable or explosive mixture in-flight than the gasoline-type fuel. Lastly, the fire hazards after a survivable crash or following a minor incident on the ground are reduced by the use of kerosene-type fuels.
