Evacuation Slide Test

**FAA Fire Safety Team
FAA Wm. J. Hughes Technical Center
Atlantic City International Airport, NJ 08405**

Heat Resistant Evacuation Slides

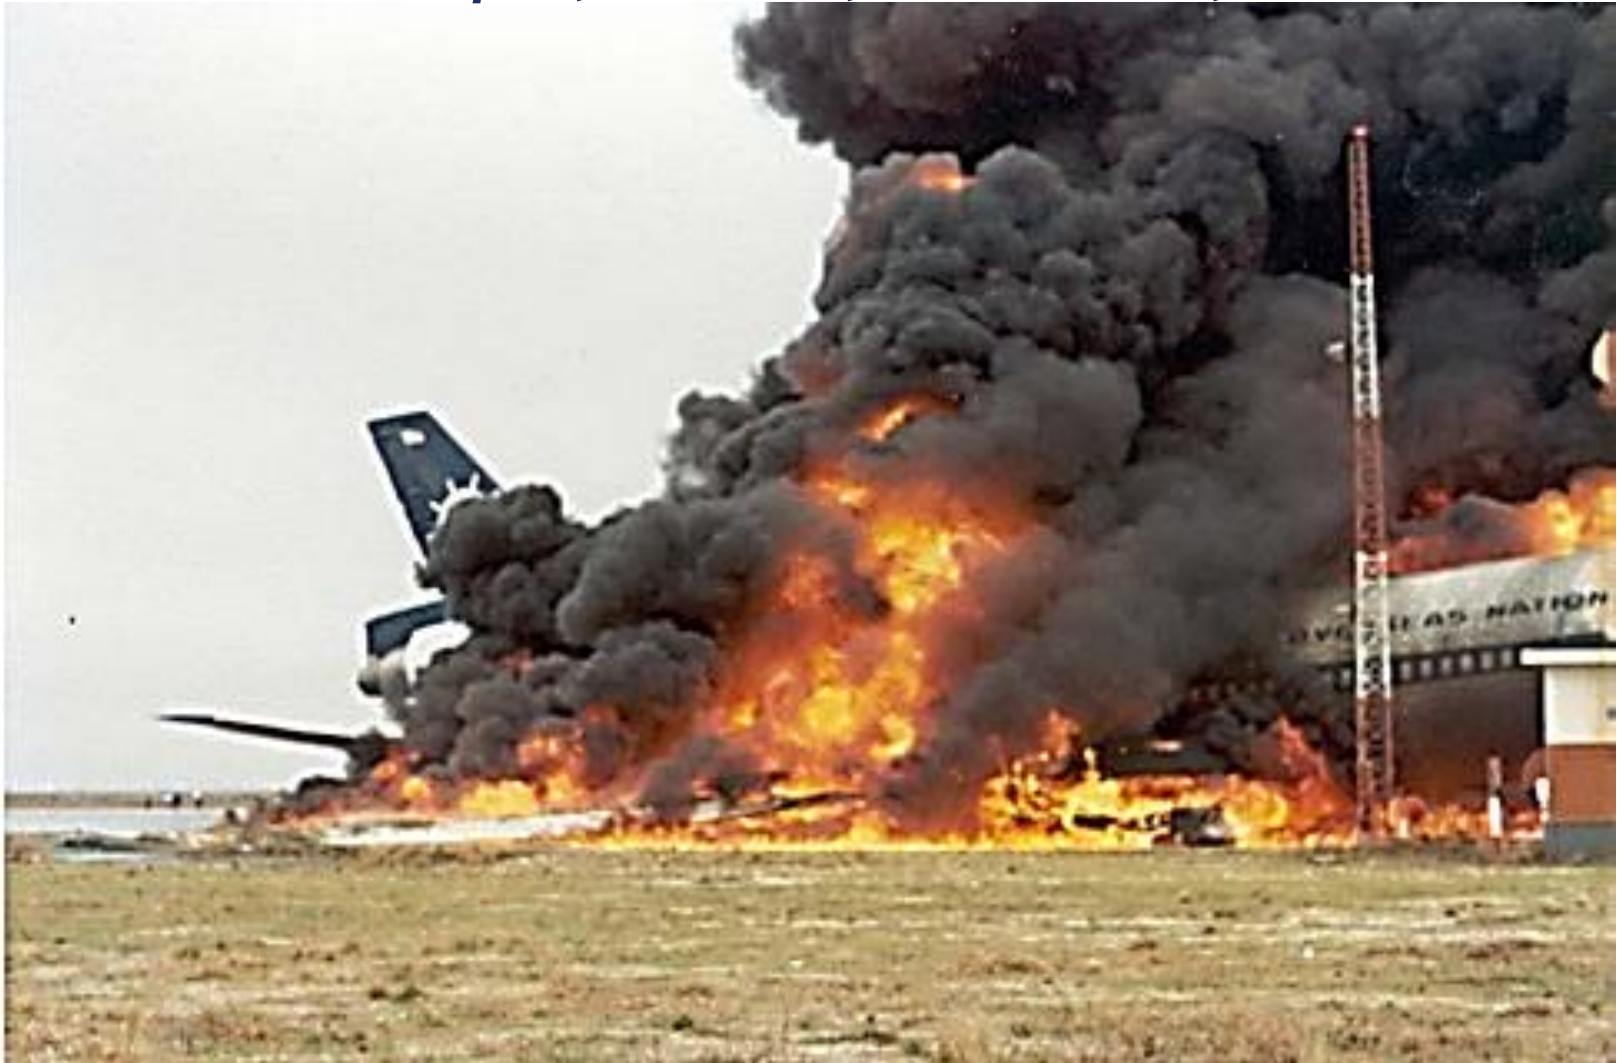
Overseas National Airways DC-30

JFK Airport, New York; November 12, 1975

Rejected Take-off after striking flock of birds, engine #3 catches fire

129 Passengers, 10 Crew

Successful evacuation attributed to passengers being employed by airline

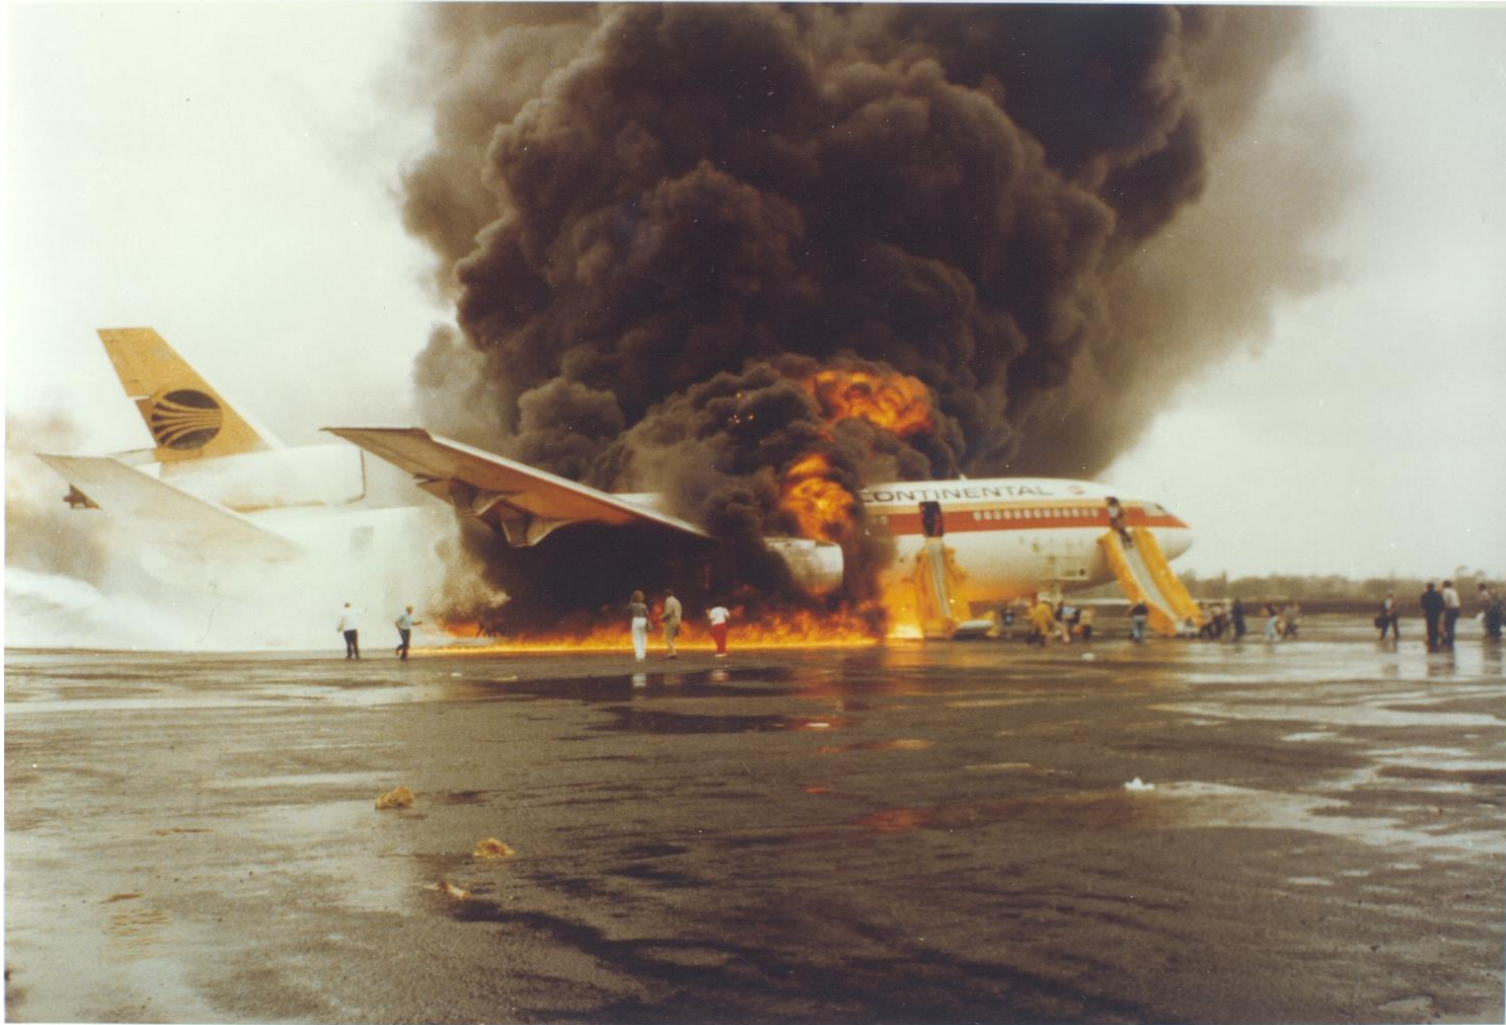
Continental DC-10

Los Angeles, California; March 1, 1978

Rejected Take-off after 2 tires failed, airplane goes off end of runway

Left main landing gear collapses, a fire begins in this area

186 Passengers, 14 Crew

2 Fatalities

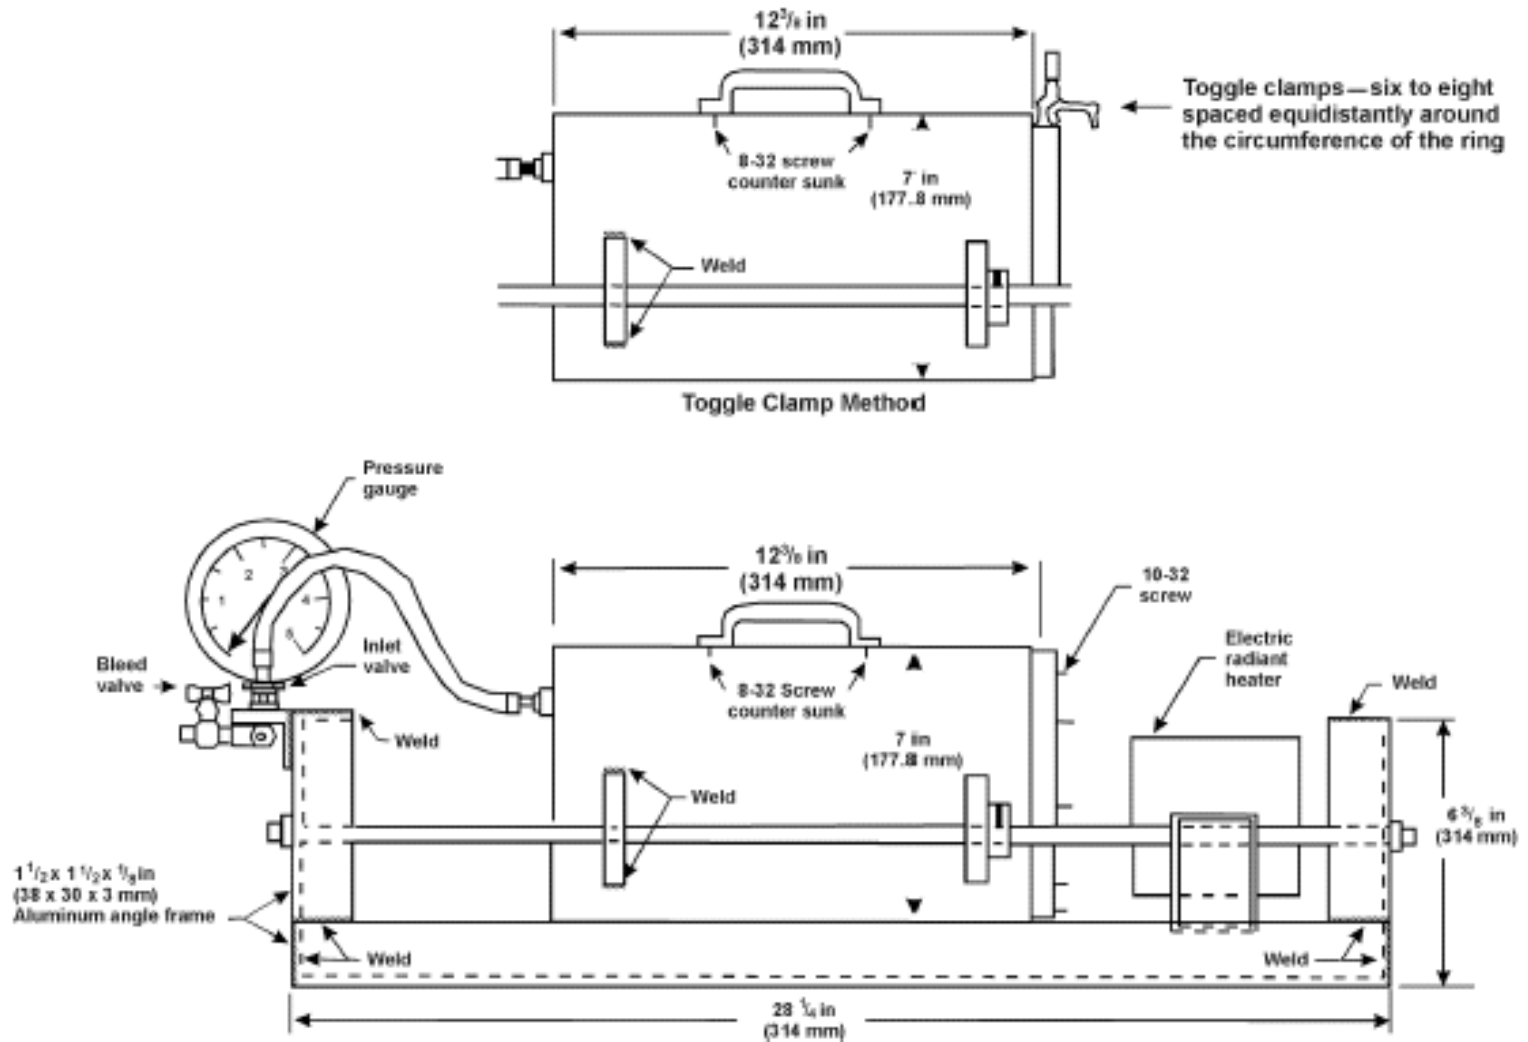
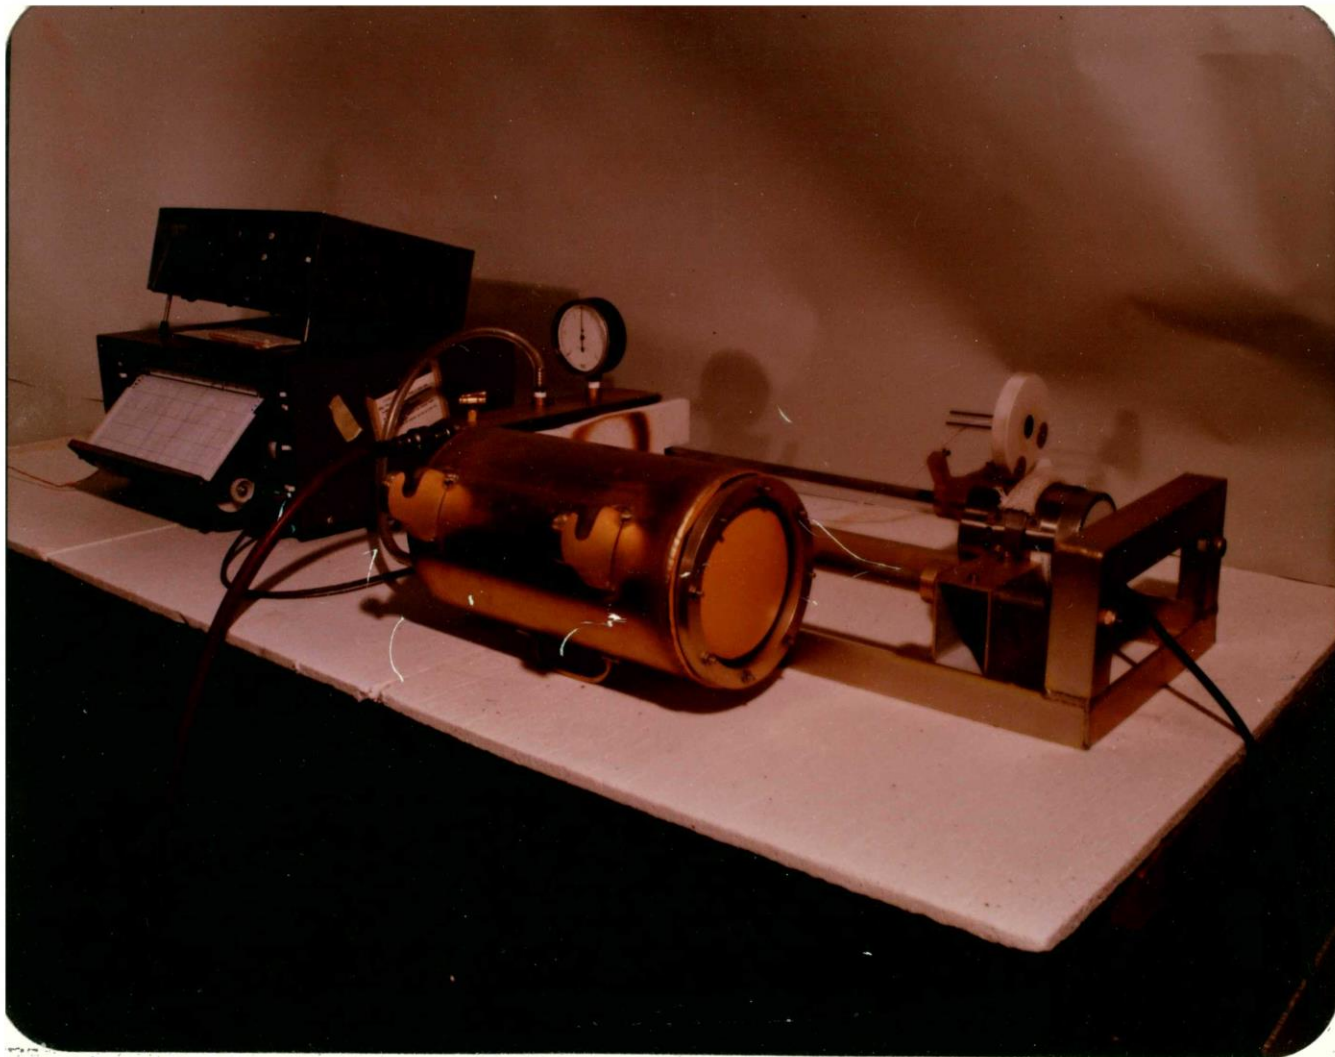
Evacuation Slide Material Test Apparatus

- Radiant Heat Exposure
- Pressurized Slide Fabric Sample
- Measures Pressure

Record Time to first observed pressure loss

Average Time to Failure (3 Specimens): > 90 seconds
