Radiant Panel Update

Presented to: International Aircraft Materials Fire
Test Working Group Meeting
By: Steven Rehn
Date: 3/6/2018

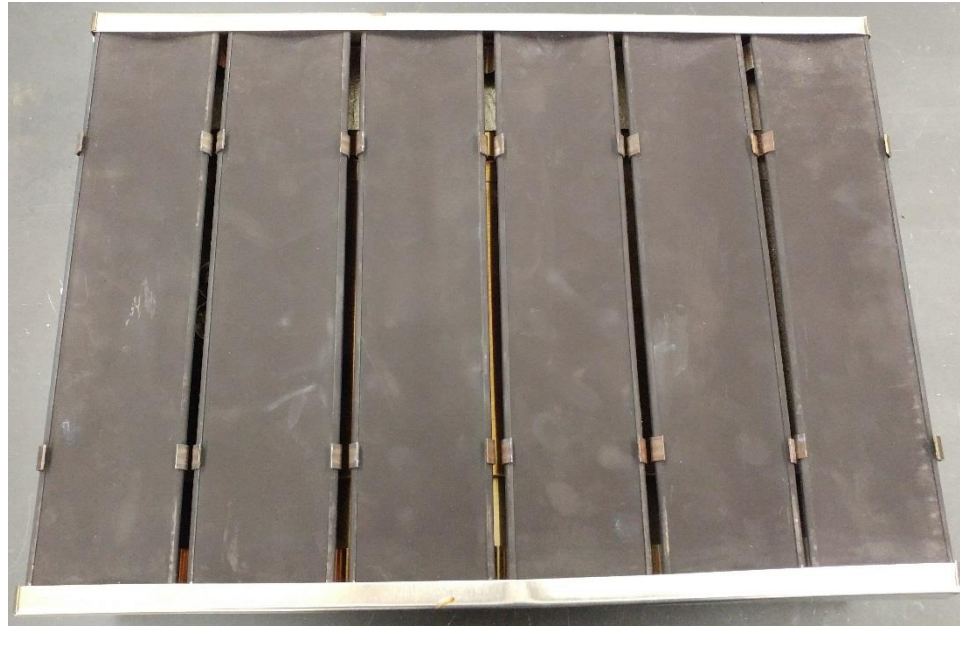
New Panel

- Temperature set point steadily increases to obtain same heat flux as panel ages – eventually leads to more material failures
- Biggest difference seems to be black paint on surface
- Need to add guidance about when to replace electric panel

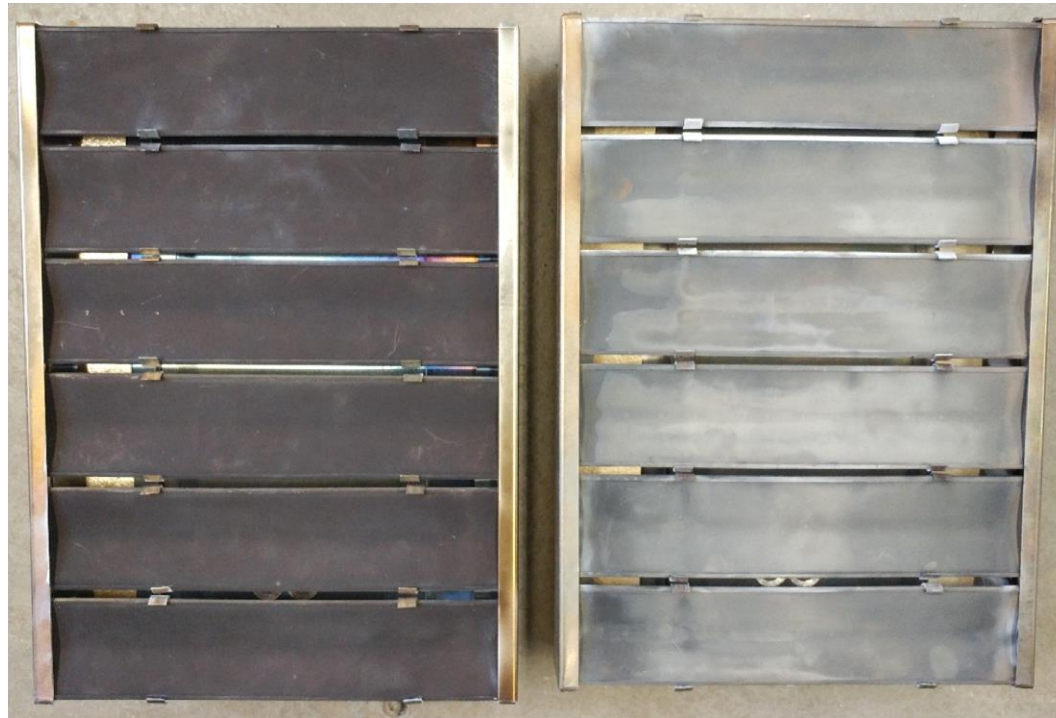
New Panel

Set Point: 1073°F

Heat Flux: P0: 1.502 Btu/ft²s

P1: 1.473 Btu/ft²s

P2: 1.398 Btu/ft²s

Old Panel

Set Point: 1121°F

Heat Flux: P0: 1.503 Btu/ft²s

P1: 1.493 Btu/ft²s

P2: 1.408 Btu/ft²s

- **Planned to test if old panels can be refurbished by repainting the surface**
- **Run calibrations and material tests with new panel, old panel, and repainted old panel**
- **Test 15 samples with each panel setup – 5 Polyimide, 10 Metalized PEEK**
- **Determine if repainted panel performs as well as a new panel**

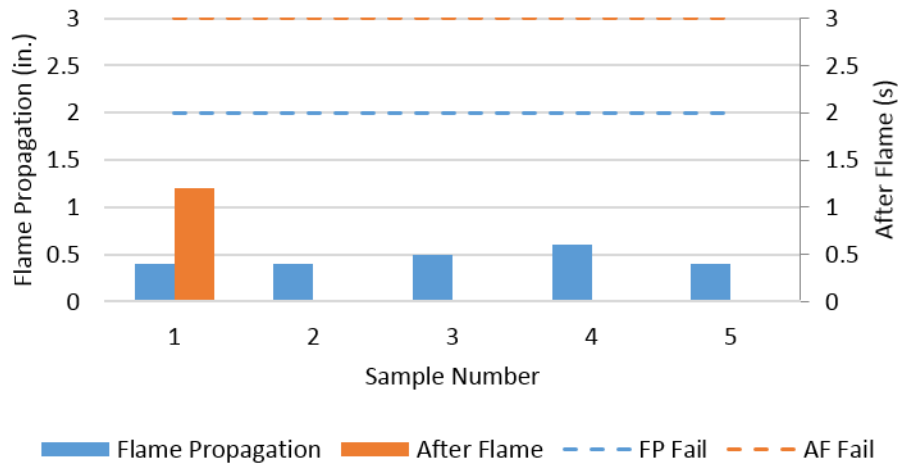
New Panel - Polyimide

- Polyimide material – 5 each

- Old panel did not perform worse than new panel

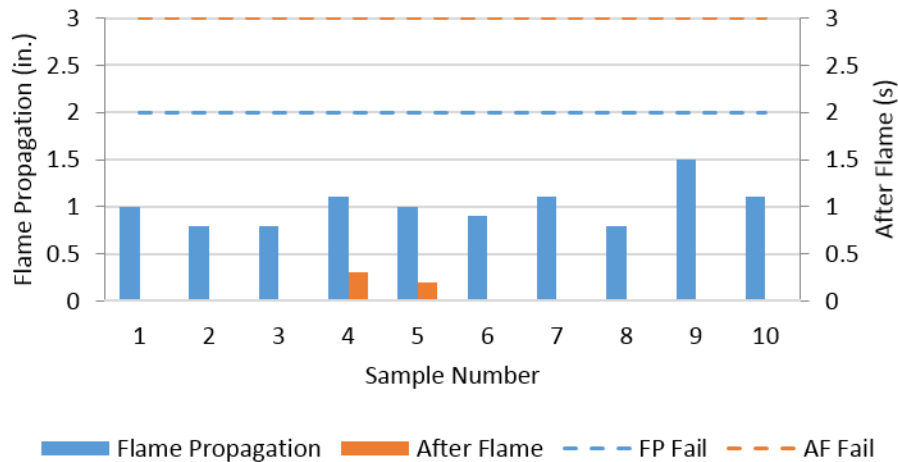
New Panel - Metalized PEEK

- Metalized PEEK material – 10 each

- Old panel did not perform worse than new panel

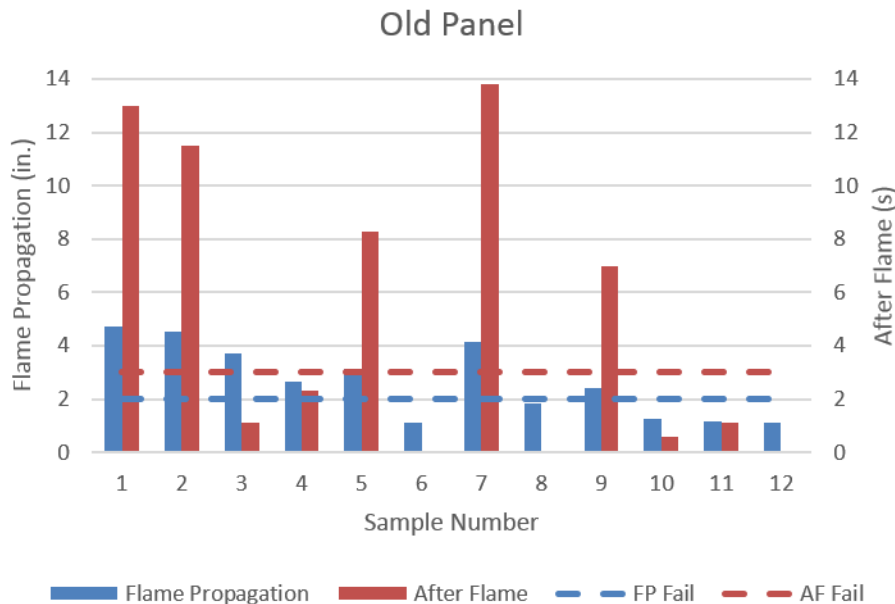
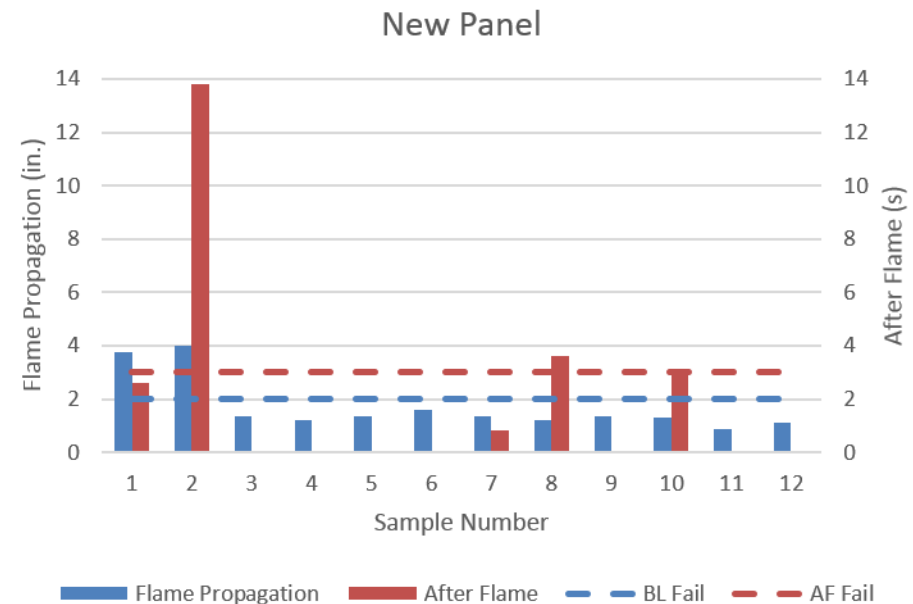
- During 2015 round robin, the lab with the most test failures replaced their (over 10 year-old) panel and repeated their test

Old Panel:

Set Point: 1211°F
Heat Flux: 1.501 Btu/ft²s
7 material failures

New Panel:

Set Point: 1105°F
Heat Flux: 1.501 Btu/ft²s
4 material failures

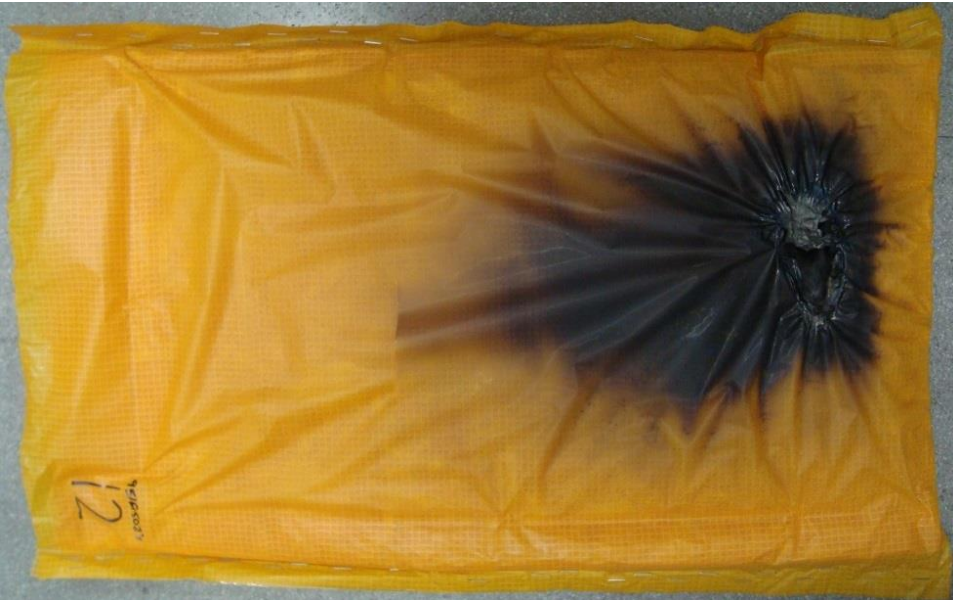
Old Panel

- **Polyimide comparison**

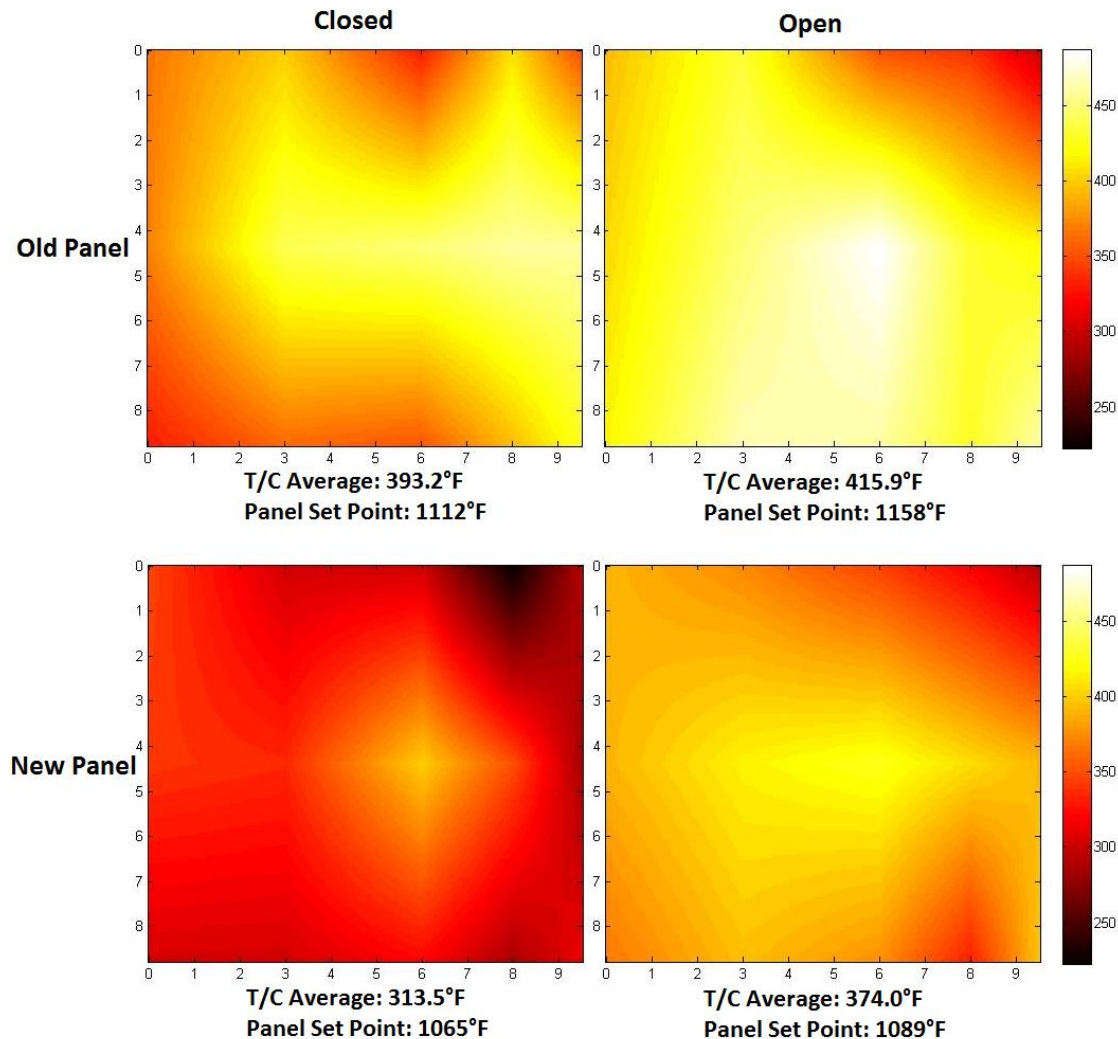
- 15 Thermocouple array at test sample surface
- Measured surface temperatures with old panel, new panel, and at two different air gap configurations around the sliding platform
- In the open configuration:
 - Old panel had higher set point, 1158°F to 1089°F
 - Old panel had higher average surface temperature, 416°F to 374°F

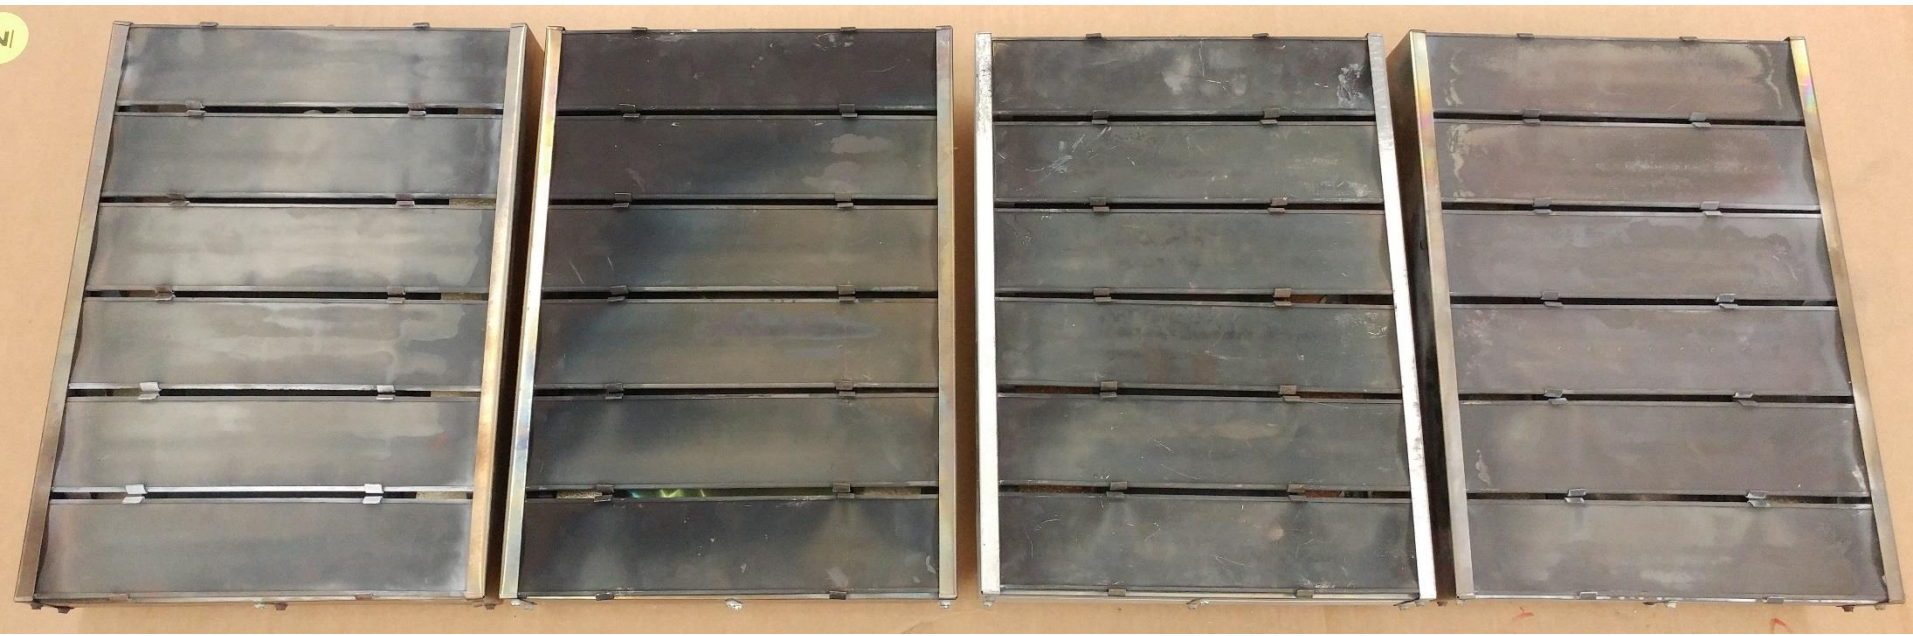
- **Now have 4 old panels from 3 different labs**
 - One panel is 12 years old!
- **Also received new metalized PEEK material**
