# Flight Deck Smoke Penetration Testing

Presented to: Systems Working Group Meeting  
Bremen Germany

By: Robert Morrison, FAA Technical Center Fire Safety  
Date: May 14 - 15, 2014

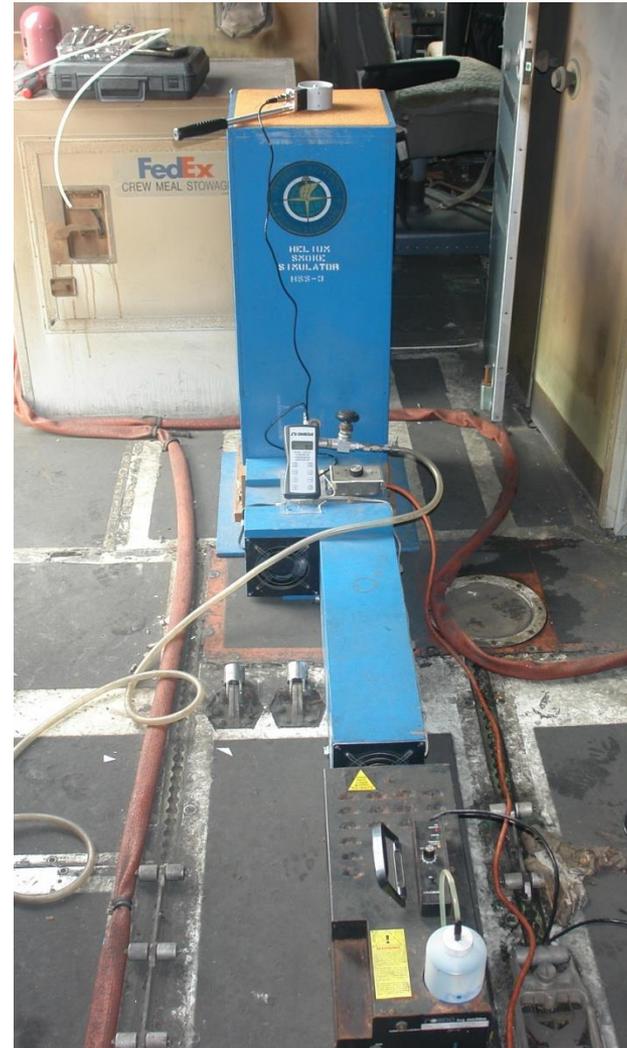
## Helium-injected Rosco 1700 theatrical smoke generator

- 50/50 Helium/Air mix, giving equivalent buoyancy properties of air heated to 490°F
  - Faint wisps of smoke coming in at rear bulkhead ceiling area above the flight deck door, smoke cleared with no measurable reduction in visibility
- 70/30 Helium/Air mix, giving equivalent buoyancy properties of air heated to 940°F
  - Visible smoke in flight deck after 3 minutes from helium injection.
  - Light to medium obscuration at end of 20 minute test.

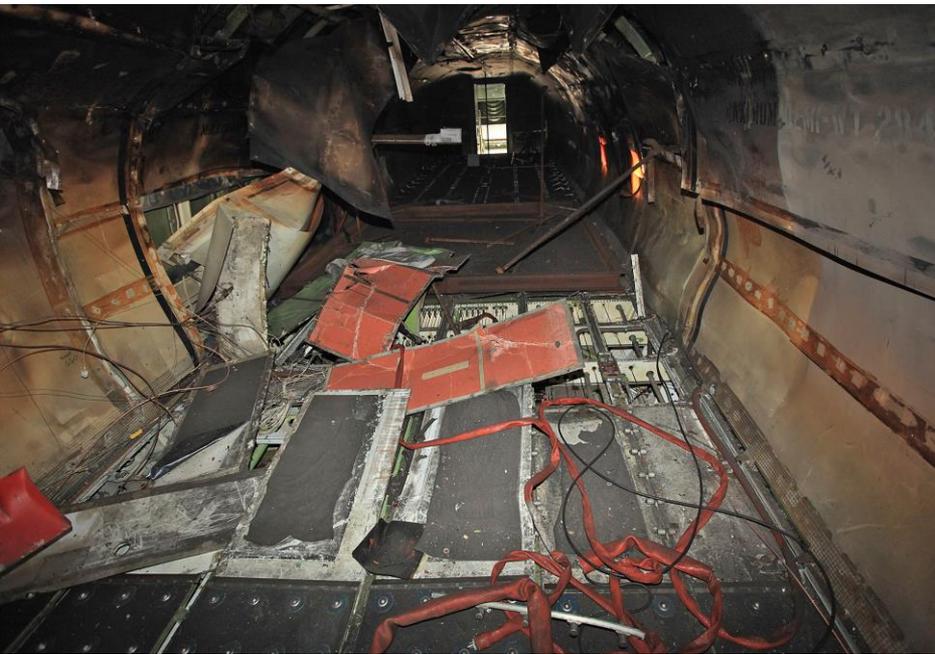
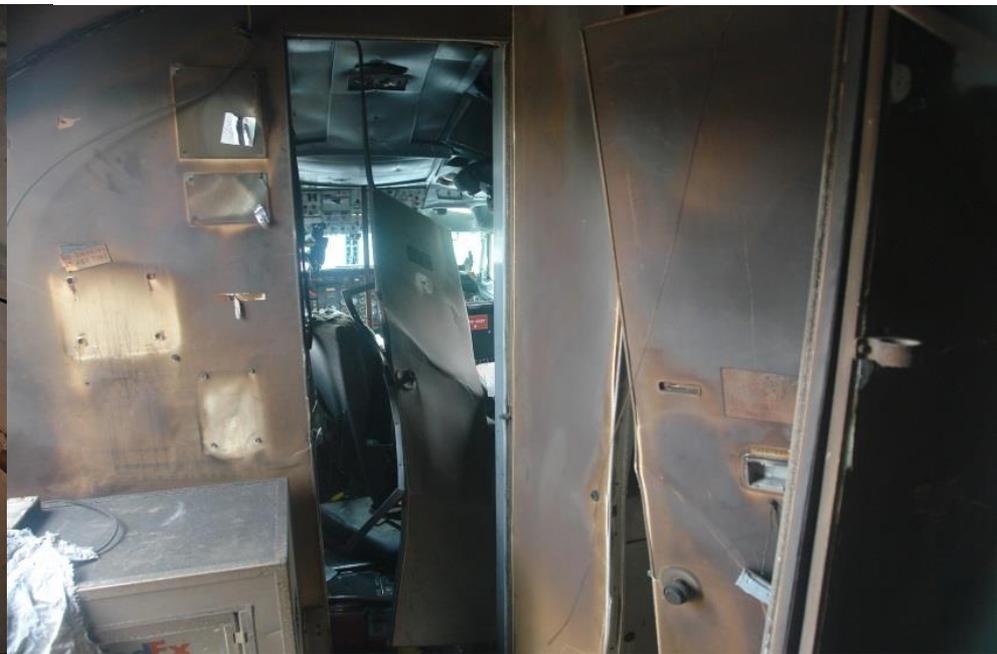
- A retest is required due to the failed recording of the reduction of light transmissibility parameter on the 70/30 Helium/Air mix test.
- Before the retest could be accomplished, the final lithium primary battery test (test 10 of 10) was run and resulted in an explosion in the Class C cargo/ECS compartment which blew out a 20 x 10 section of the floor and ruptured all under floor ECS ducting.

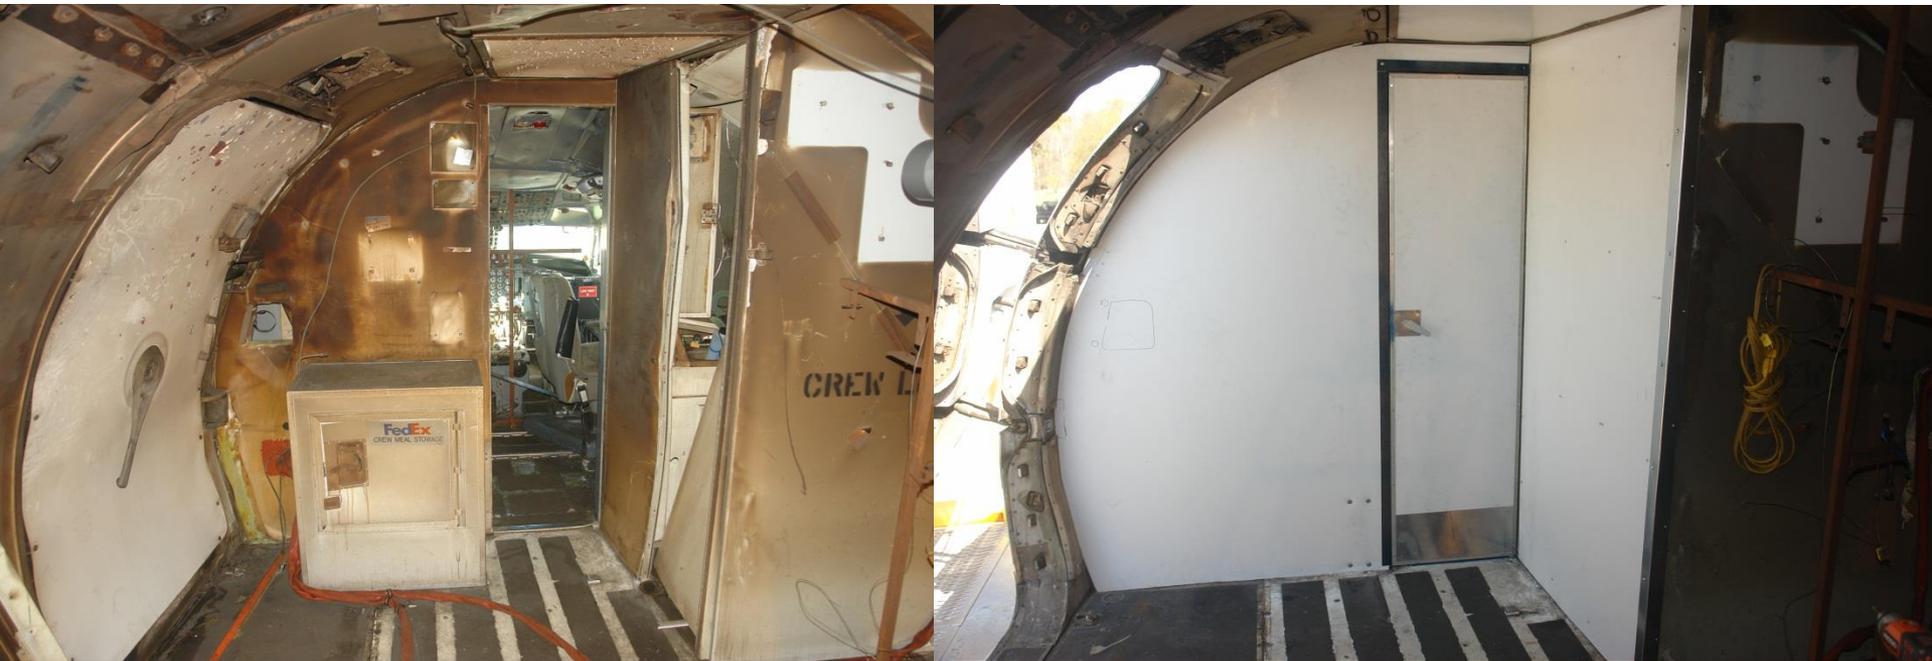
- The overhead air conditioning duct network in the main cargo area has been replaced
- The flight deck bulkhead has been reconstructed
- The forward cargo compartment is being repaired and the lower air conditioning duct system is being installed
