TECHNICAL DEVELOPMENT REPORT NO. 334

EVALUATION OF THE FIRE EXTINGUISHING
SYSTEM ON A MODIFIED PBY AIRPLANE

EVALUATION OF THE FIRE EXTINGUISHING SYSTEM ON A MODIFIED PBY AIRPLANE

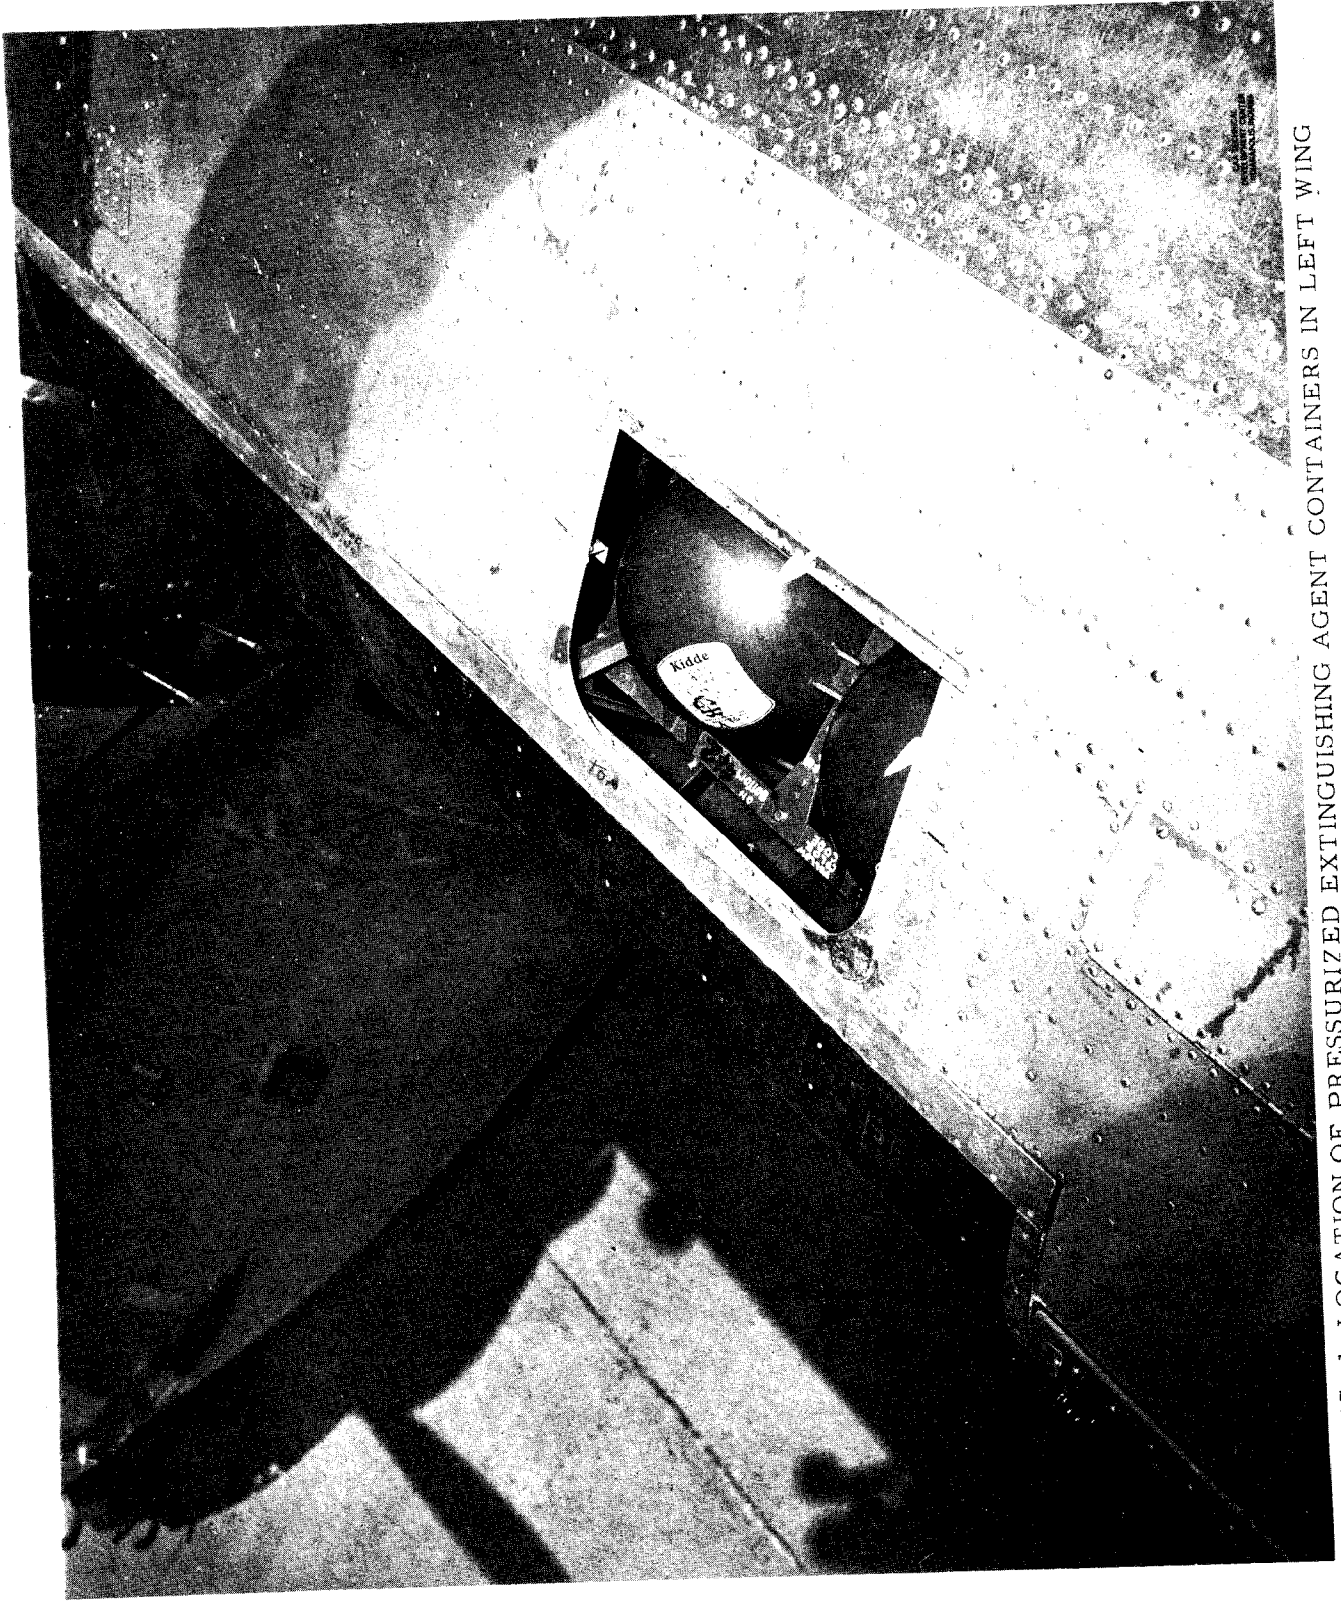
FIG. 1 LOCATION OF PRESSURIZED EXTINGUISHING AGENT CONTAINERS IN LEFT WING

The engine nacelles of the airplane were protected only in Zone 2 (accessory compartment) and Zone 3 (oil tank and propeller feathering pump compartment) by a newly installed Walter Kidde extinguishing system which consisted of two 536-cubic-inch spherical containers and distribution tubing. Zone 1 (forward compartment) was not protected. The containers were located in the leading edge of the left wing about four feet outboard of the No. 1 engine as shown in Fig. 1. Each container was charged with 15 pounds of CBrF_3 (bromotrifluoromethane) and pressurized to 350 pounds per square inch (psi) with nitrogen. These containers provided a main and spare charge of agent for extinguishing a fire. Check and directional valves in the distribution system make it possible to discharge agent from these containers into either nacelle.
